## QUINQUENNIAL INSPECTION REPORT 2021

Location	:	31 Upper Church Road, St Leonards on Sea
Parish	:	The Parish of the Good Shepard St Leonards-on-Sea

Report Prepared by:  
Nicholas Lee Evans  
Lee Evans Partnership LLP  
St Johns Lane  
Canterbury  
Kent CT1 2QQ

Inspection : July 2021

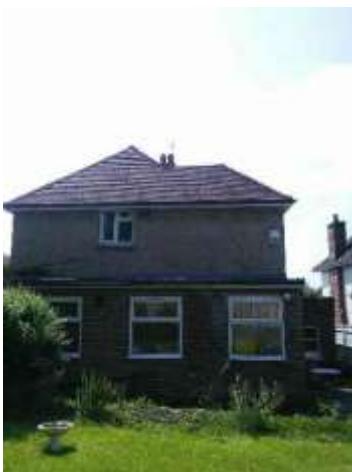
#### 1.1.2 **North Roof**

Good

Some moss starting to grow on tiles noted.

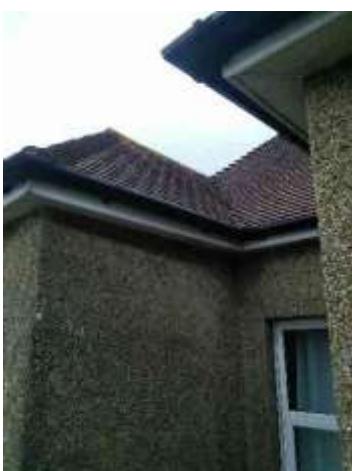
#### 1.1.3 **West Roof**

Good

There are also patches of moss growing on this roof.

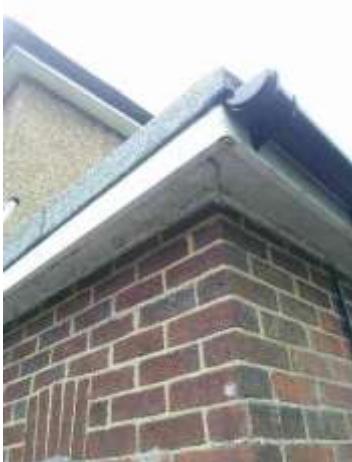
### 1.1.7 Flat Roof Over Kitchen Soffits

C - Up to 5 years

Needs Repair

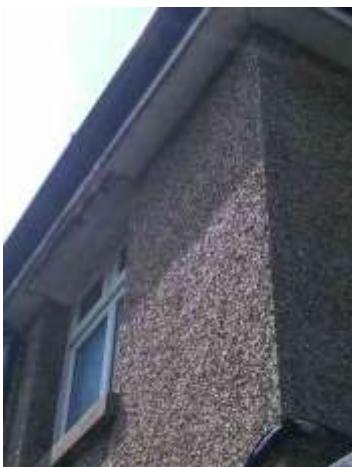
### 1.1.8 Soffits Generally

C - Up to 5 years

Needs Maintenance

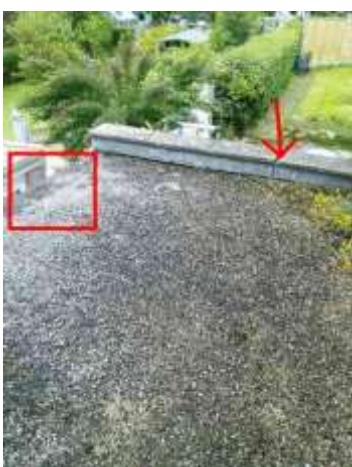
### 1.1.9 Garage Roof

The garage roof is covered with roofing felt which has decayed and has torn along the West side as it is dressed into the gutter. Water now pours down the side of the wall and this is probably contributing to the walls are cracking in this area. This is most important repair needs to be undertaken soon and needs to be done before the brickwork repairs are carried out.

Needs Repair

Felt roof with tear in lead flashing which needs repair and torn front edge of felt as it goes into gutter which needs repair. See below.

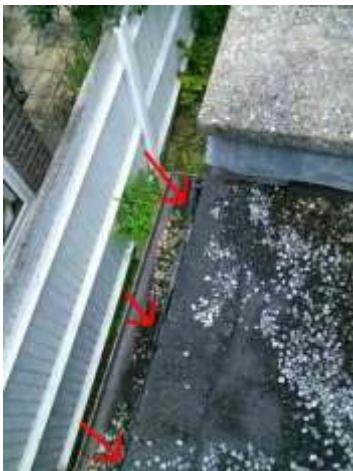
### 1.1.10 Garage Roof Edge

B - Up to 2 years

Needs Repair

The front edge on the western side of the garage has felt dressed into the cast iron gutter. This felt has split and is now letting the water coming off the roof into the garage wall and needs repairs. The gutter also needs cleaning.

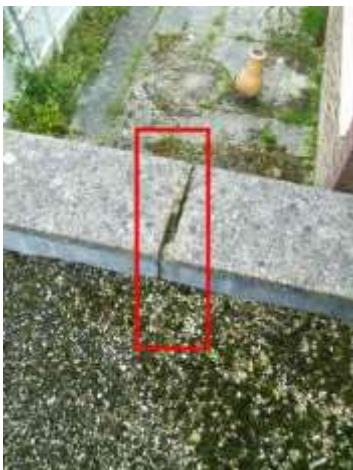
### 1.1.11 North Side of Garage Roof

B - Up to 2 years

Needs Repair

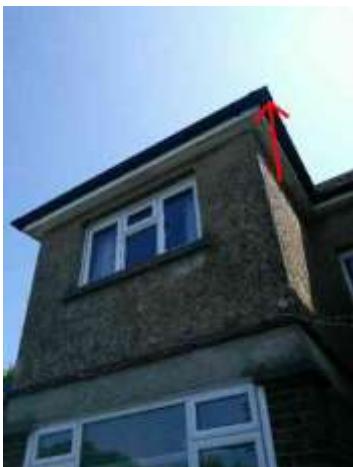
### 1.2.1 Rainwater Goods to House

There is also a persistent dripping leak from a blocked gutter in the Southwest corner of the back bedroom. I recommend the gutters are cleaned by a professional gutter cleaner to see if this deals with the leak and if not the fixings need to be tightened up on the gutter.

M - Routine Maintenance

Plastic gutters and downpipes which need cleaning as overflowing in southwest corner above kitchen

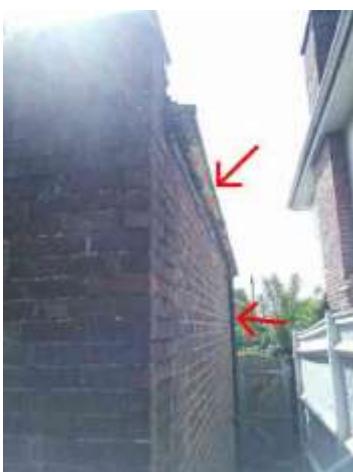
### 1.2.2 Garage Gutter

Most of the rainwater goods are plastic and in good condition. There is an original OG cast-iron gutter on the west side of the garage which discharges into a rainwater pipe both of which need decoration and the gutter needs cleaning out.

B - Up to 2 years

Needs Repair

Cast iron gutter which needs decoration and cleaning

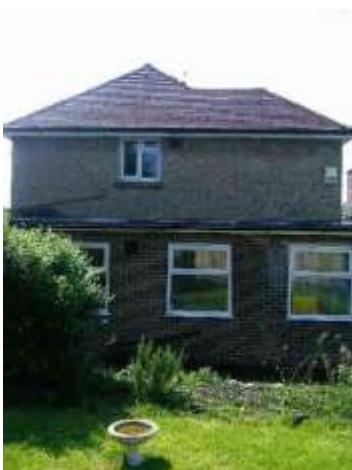
### 1.4.2 North Wall

Good

Pebble dash first floor solid walls with brick walls to ground floor. Modern kitchen extension. Some old water staining where gutter has overflowed. The windows are plastic and double glazed.

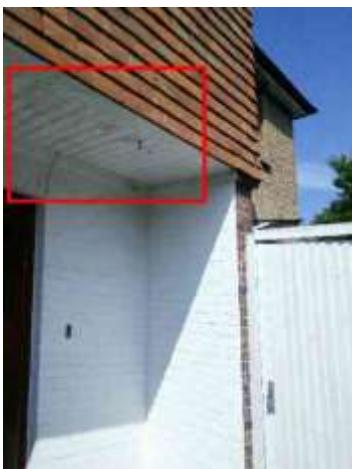
#### 1.4.4 East Wall

C - Up to 5 years

Needs Repair

East Wall: Pebble dash first floor walls except over entrance where there is a tiled bay and painted boarded ceiling by front door. These boards are starting to grow sooty mould and will need painting before end of quinquennium. Red face brick walls with painted bricks in entrance bay.

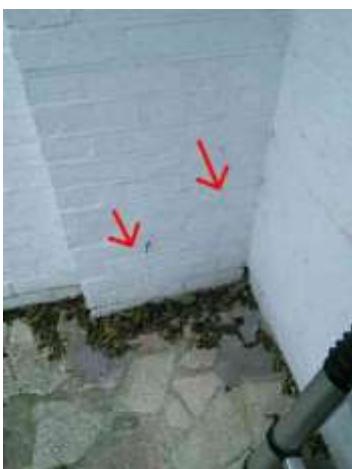
#### 1.4.5 Movement South Side Front Door

O - Keep under observation

Crack South Side of Front Door: There is a hair crack noted to south side of front door.

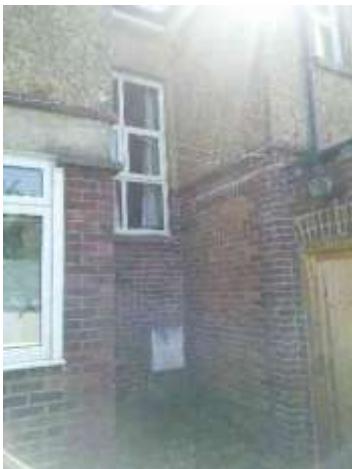
#### 1.4.6 West Wall

Reasonable

Pebble dash first floor windows with brick ground floor and rendered concrete over dining room window. Render broken on stair window will (see windows).

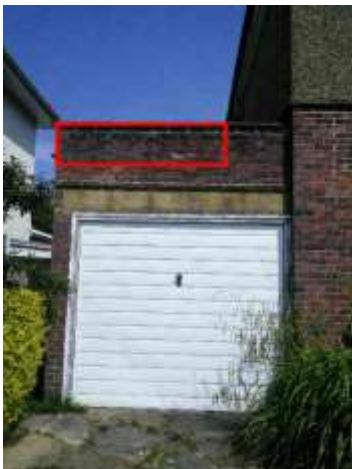
#### 1.4.7 Garage South Wall

B - Up to 2 years

Needs Repair

Red face brick wall with rendered lintel and painted metal garage door. The pointing above roof level needs repair.

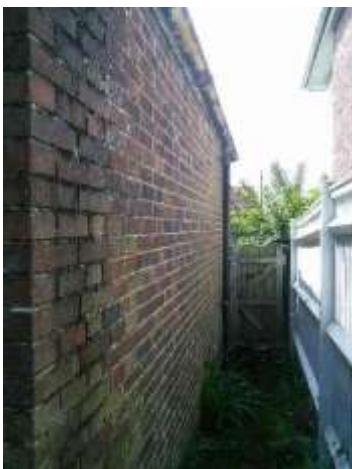
#### 1.4.8 Garage West Wall

Fair

Face brick wall which is damp especially in northern corner where the felt is split above.

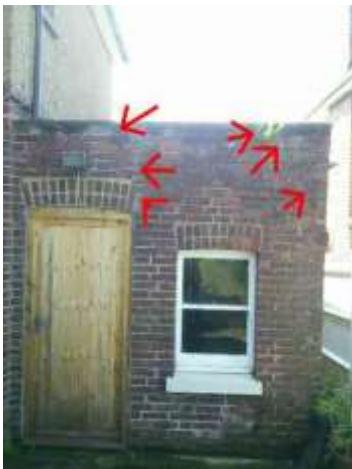
#### 1.4.9 Garage North Wall

B - Up to 2 years

Needs Repair

Garage North Wall: Red face brick wall which is cracking over door and in northwest corner at high level. There is a plant growing in the wall. The brickwork needs reinforcement and repair and the plant and all its roots removing.

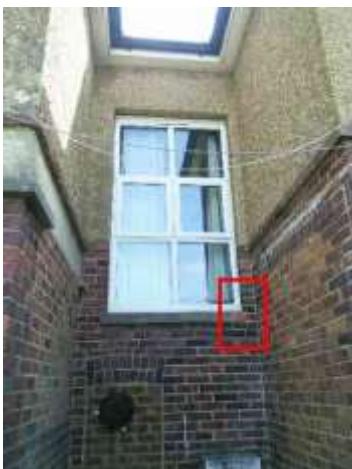
##### 1.5.2 Stair Landing Window Sill

The window sill to the stair window and the sill to the eastern bedroom on the front elevation have both lost a piece of their render covering to the brick underneath and need repair.

B - Up to 2 years

Needs Repair

The render has come off the windowsill to the stair landing window and this needs to be repaired.

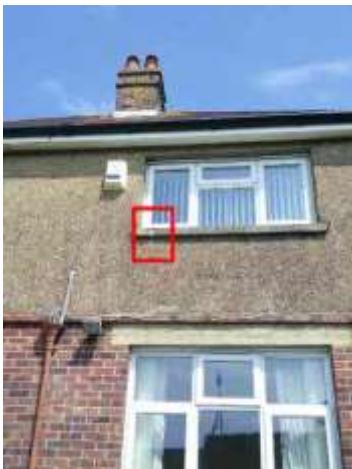
### 1.5.3 Front East Bedroom Window Sill

C - Up to 5 years

Needs Repair

Render has come off the front east bedroom window sill and this needs repair.

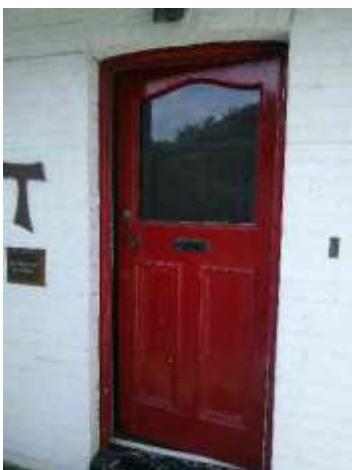
### 1.5.4 Front Door

C - Up to 5 years

Needs Repair

Front Door: Painted wooden door with obscured glass panel. Step needs repainting where paint chipped.

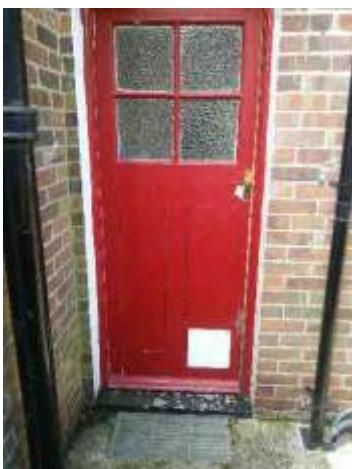
### 1.5.5 Back Door

The doors are generally made of timber and in reasonable condition although the back door has some animal scratch marks which should be redecorated over and both the front door and back door sills are chipped and need painting in this quinquennium. The back door to the garage needs decoration in this quinquennium.

C - Up to 5 years

Needs Repair

Back Door: Painted wooden door with obscured glass panel. Step needs painting where chipped. The door has animal scratch marks which need painting.

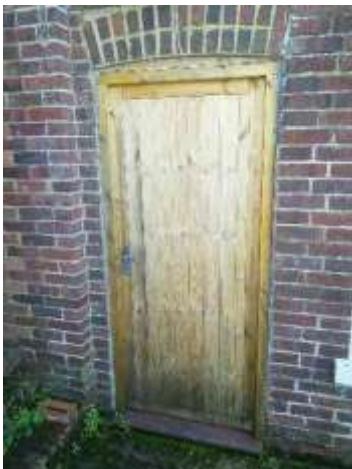
## 1.5.6 Garage Doors

B - Up to 2 years

Needs Repair

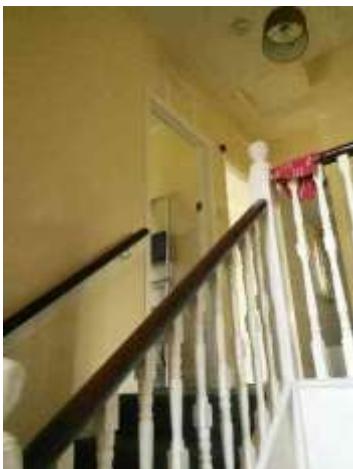
### 2.2.1 Staircase

Reasonable

Painted ceiling and textured papered walls. Painted timber balustrades and varnished handrails. Small splash stain below handrail on topflight. Carpet on floor.

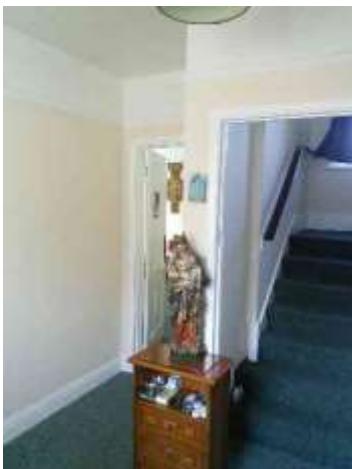
### 2.6.1 Hall

B - Up to 2 years

Hall: Plastered walls and ceiling, carpet on floor. Walls lined with lining paper below dado rail. Well decorated. Old painted over cracks noted on ceiling. Painted cupboard by front door. Cupboard catches no longer working and need replacing.

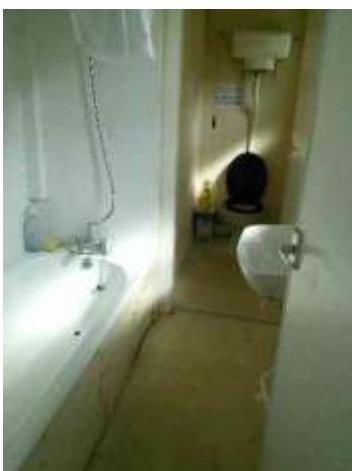
#### 2.6.6 Ground Floor Bathroom

The bathrooms and kitchens are in good order generally. However, the bath panel to the ground floor bath is severely rusted and needs replacing in this quinquennium.

There is a small damp patch at the back of the ground floor toilet cubicle which needs to be repaired when it is next decorated.

B - Up to 2 years

Ground Floor Bathroom: Plastered walls and ceiling, sheet vinyl on floor. WC and basin in cubicle with textured papered walls which is just starting to peel low down to right of toilet. Tiled splashback to bath and basin. Cast iron bath with shower over. The rusting bath side panel needs replacing. Door is hard to shut and needs easing.

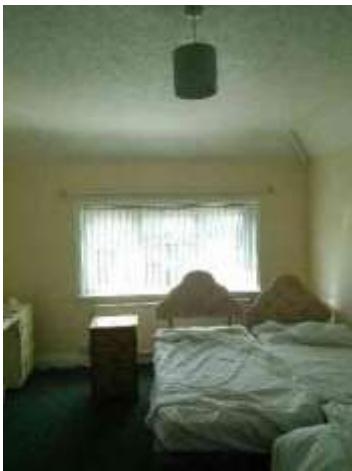
### 2.6.7 Bedroom 1

Internally, the walls and partitions are generally in good order. The door to the front west bedroom is sticking and does not fit the opening well and need some adjustment. This may be because of some local settlement in the house over time but there are no obvious cracks in the vicinity.

C - Up to 5 years

Bedroom 1 front west side: Textured painted ceiling and lining papered walls, painted skirting, carpet on floor. Slightly poor underlying plaster where fireplace removed. Door does not fit well on top and is catching on the carpet and needs some adjustment.

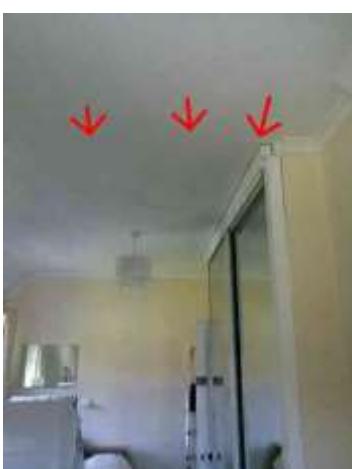
### 2.6.9 Bedroom 3 Rear West

There is some cracking in the back bedroom which runs down the ceiling to the wall which needs to be kept under observation but I respect it is historic.

O - Keep under observation

Bedroom 3 Rear: Textured painted ceiling and lining papered walls, painted skirting, carpet on floor. Paper peeling on south wall behind bed and needs to be stuck back. Crack noted on ceiling in line with end of the cupboard which needs to be kept under observation. Basin and splashback and sliding door cupboards.

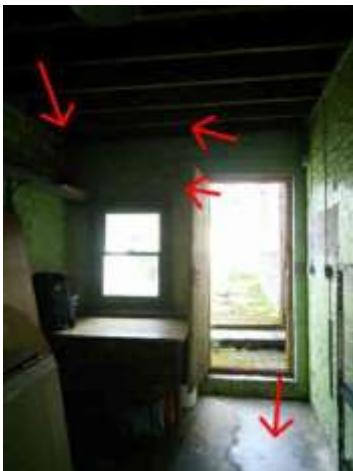
## 2.6.13 Garage

A - Urgent/ Up to 12 months

Needs Repair

The garage has a one brick thick wall painted on inside with central crack on rear wall which needs attention. The ceiling is joisted with boarding over and a leak in northwest corner. The concrete floor slopes and, in heavy rain, water flows from paths outside under the door.

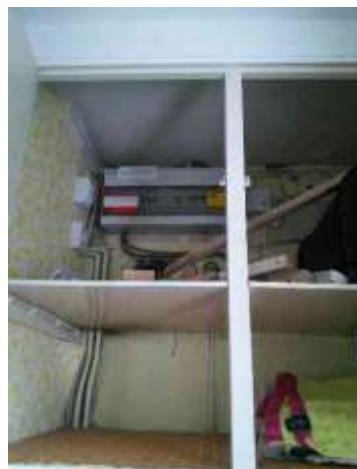
### 3.2.0 Electrical

A - Urgent/ Up to 12 months

Needs Repair

Electrical test done in 2009 according to sticker on unit and therefore overdue for its 5 year periodic inspection.

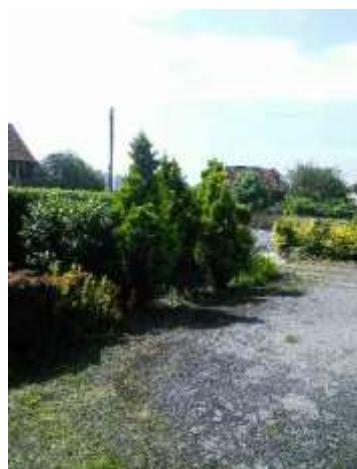
##### **4.1.1 Southern Boundary**

Reasonable

Hedge over low concrete wall with slight lean to the low wall beneath the hedge noted.

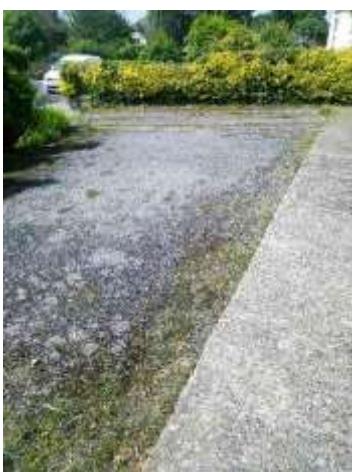
#### 4.2.1 Paths

B - Up to 2 years

Needs Repair

Parking: Parking on tarmac for a couple of cars with concrete and broken paving paths and bricks on edge. The tarmac needs topping in this quinquennium

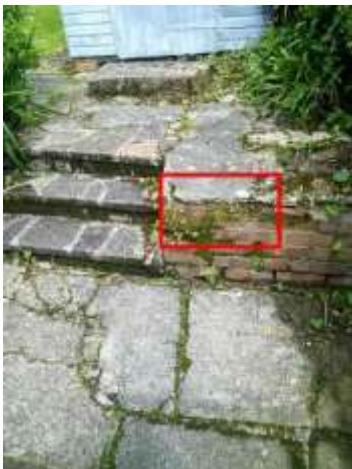
#### 4.2.3 Brick Retaining Wall by Shed

Fair

There is a low retaining wall by the shed where the bricks are starting to decay.

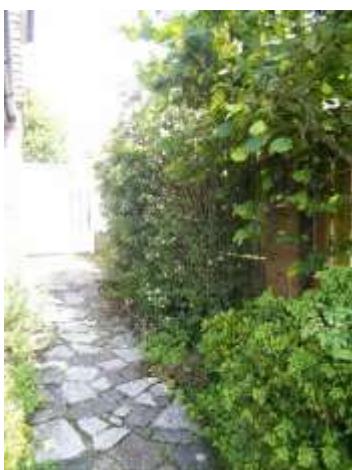
#### 4.2.4 Paths to Front Door

The crazy paving path to the front door has lost most of its mortar between the broken stones and needs repaired soon to prevent a trip hazard.

B - Up to 2 years

Needs Repair

The path to the front door needs pointing in patches so it is not a trip hazard.

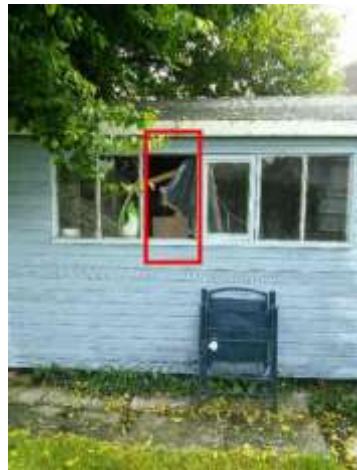
### 4.3.2 Shed

There is a garden behind the house which is kept neat and tidy. There is a shed in the back garden whose base has risen probably due to the action of the roots of the adjacent tree. One panel of glass in the window facing the garden is missing and needs replacement soon.

A - Urgent/ Up to 12 months

Needs Repair

Timber boarded shed with felt roof which has been patch repaired. Glass missing from one window which needs a repair. The shed is leaning slightly as the base has moved so it leans.
