## QUINQUENNIAL INSPECTION REPORT 2021

Location, Dedication	:	The Church of The Holy Redeemer
Parish	:	The Parish of The Good Shepherd, St Leonards-on-Sea

Inspection : 25<sup>th</sup> June 2021

First Issue 30<sup>th</sup> August 2021

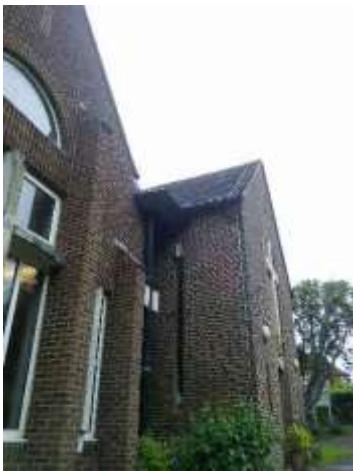
### 1.1.3 Nave East Slope

**Condition:** Good

Concrete pantiles and clay ridge tiles.

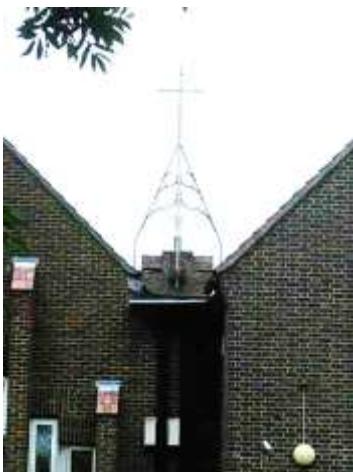
### 1.1.5 Spire

**Condition:** Reasonable

Metal spire on brick wall with tiled capping.

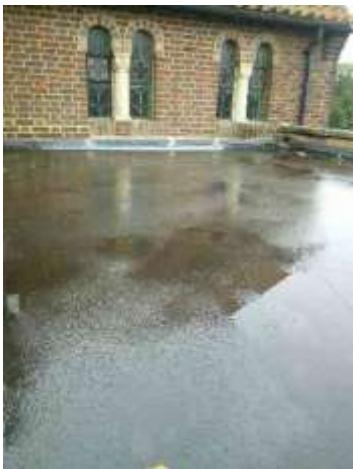
### 1.1.9 Sacristy Roof

**Repair Priority:** D - Desirable Improvement

**Condition:** Reasonable

The Sacristy asphalt roof ideally would have a solar reflective coating to prolong the asphalt's life.

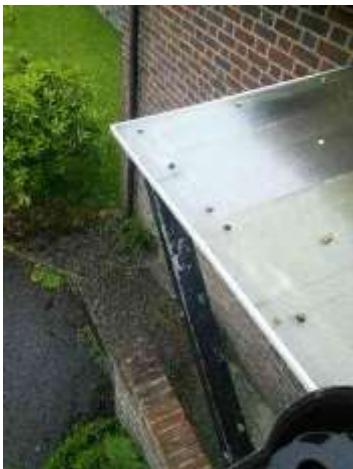
### 1.1.10 Canopy To Sacristy Door

**Repair Priority:** C - Up to 5 years

**Condition:** Needs Repair

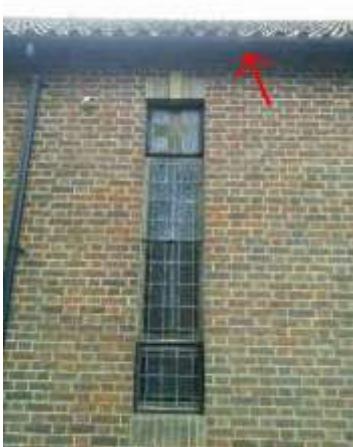
### 1.2.3 Gutter Leaking North Wall By West Window

**Repair Priority:** B- Up to 2 years

**Condition:** Needs Repairs

There is a gutter leak by the west window on the north wall which needs repair and the gutter cleaning.

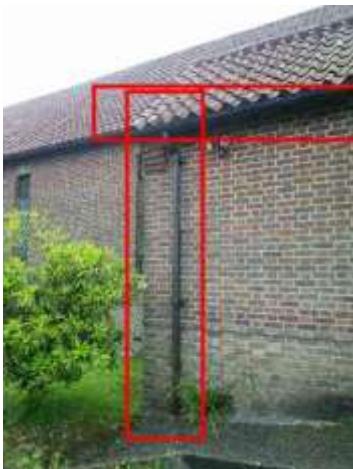
#### 1.2.4 Rainwater Pipe To Vestry

**Repair Priority:** B - Up to 2 years

**Condition:** Needs Repair

Gutter to Vestry by the ramp on the north elevation:  
The rainwater pipe is probably blocked and needs  
cleaning and redecoration.

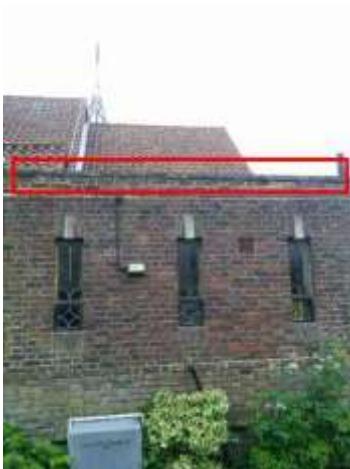
### 1.3.2 Sacristy Parapet

Where parapet walls have been rebuilt around the Vestry, to incorporate the new damp course, pointing is falling out which is unsightly but of little concern. Ideally it would be repointed but this is not a high priority as the way the damp proof course has been inserted means any pointing is unlikely to stay in place. Notwithstanding this issue the damp proof course should be protecting the inside from moisture as it is.

**Condition:** Fair

Sacristy Parapet: Pointing has fallen out below parapet to the sides of modern damp proof course. It could be repaired but the position of the dpc and the size of the mortar join means the pointing is likely to fall out again.

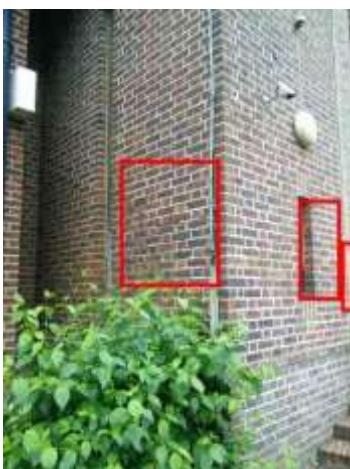
### 1.3.4 External Wall Of Stair To Gallery

The pointing to the walls is generally good but there are minor areas of pointing decay on the east and south external walls of the stair to the gallery which need patch pointing in the couple of years. There is also some pointing needed to the side of the entrance doors on the east elevation.

**Repair Priority:** B - Up to 2 years

**Condition:** Needs Repair

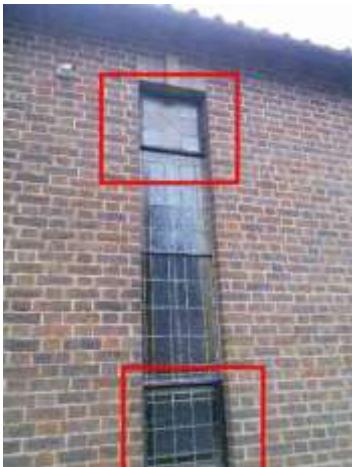
### 1.4.1 Old Church Windows

**Repair Priority:** C - Up to 5 years

**Condition:** Needs Repair

Old Church Windows: Narrow square topped lancet windows with rusting metal opening lights, with leaded glass and stained glass boarders. All the opening metal lights need painting this quinquennium with a rust inhibiting paint work such as Smooth Hammerite.

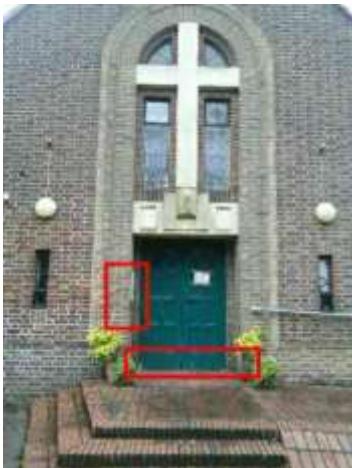
### 1.4.2 Entrance Window And Doors

**Repair Priority:** B - Up to 2 years

**Condition:** Needs Repairs

Entrance Door Window and Main Doors: Feature brick arch surround with central rendered cross on a cast stone lintel over the doors. Metal framed stained glass windows above and painted doors below. Patch-pointing need to brick arch on east side. The doors are also in need of decoration.

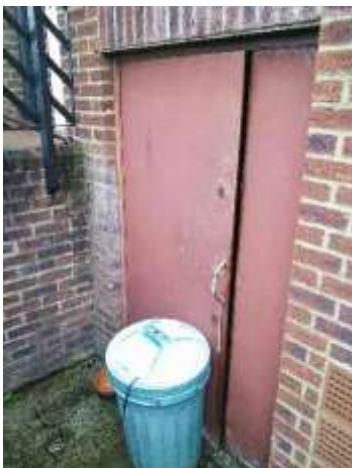
### 1.4.3 Boiler Room Door

The painted steel door into the basement is very hard to shut without a crowbar to lift it up and this needs urgent repair and the door needs painting soon.

**Repair Priority:** A - Urgent/ Up to 12 months

**Condition:** Needs Repair

Metal Boiler Room External door: In need of decoration and adjustment so it locks more easily. Currently a crow bar is needed to lift the door so it can be locked.

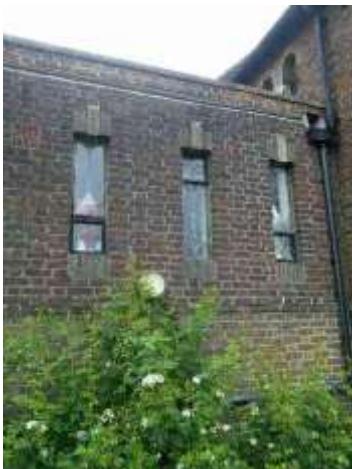
#### 1.4.5 Sacristy Windows

**Repair Priority:** C – Up to 5 years

**Condition:** Reasonable

Sacristy Windows: Narrow square topped lancets windows with rusting metal opening lights and part stained glass. All the old metal lights need painting this quinquennium with a rust inhibiting paint such as Smooth Hammerite.

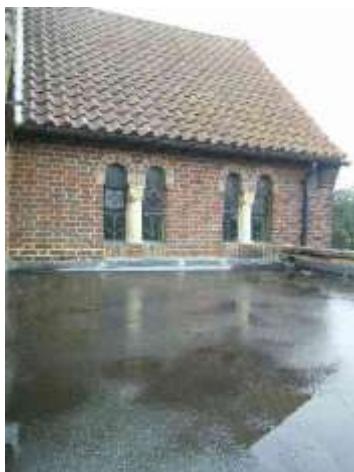
#### 1.4.9 Old Sanctuary High Level Windows

**Repair Priority:** C - Up to 5 years

**Condition:** Needs Repair

Small Romanesque windows with leaded lights and rusting opening lights which need painting.

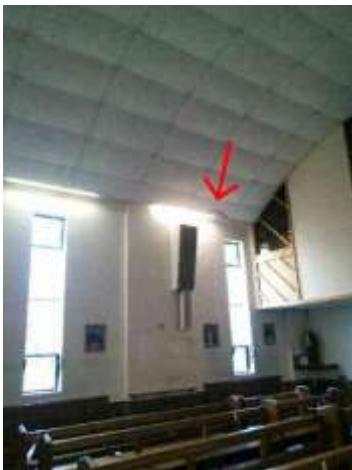
#### 2.1.2 Nave Ceiling

The main body of the Church has a barrel vaulted suspended ceiling which is generally in good order except for a couple of minor old water stains noted towards the Gallery on the north side the Church. It would be desirable to replace the affected ceiling tiles.

**Repair Priority:** D- Desirable

**Condition:** Possible Repair

Barrel vaulted suspended ceiling with old water stains noted towards gallery and above west window. The tiles could be changed to get rid of the stain.

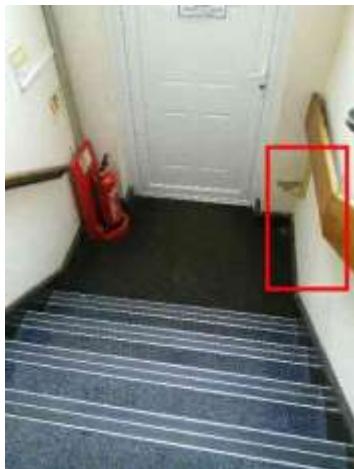
#### 2.2.4 Back Stairway

**Repair Priority:** B – Up to 2 years

**Condition:** Needs Repair

Back Stair : Concrete stair covered in carpet, an entrance mat by door. Rough cast plastered walls with paint peeling by back door which needs repair and decoration. Suspended ceiling overhead.

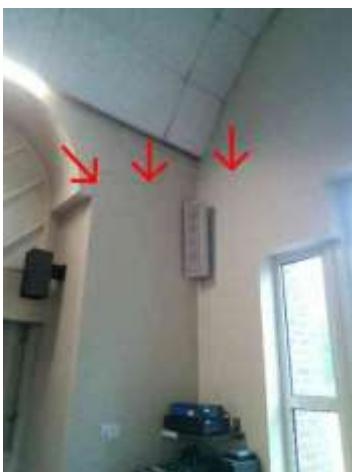
### 2.4.3 Crack North Wall above Organ

**Repair Priority:** O - Keep under observation

**Condition:** Fair

Crack on External Walls by Organ Console: High level crack, 4mm gap at worst, which needs to be kept under observation. However the crack is in a position where one may expect cracking due to differential settlement, as it is at the junction of the new and older parts of the Church.

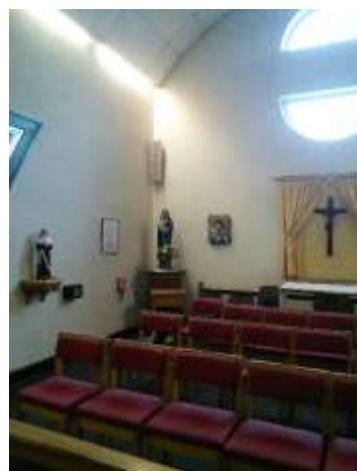
#### 2.4.6 Lady Chapel Walls

**Condition:** Reasonable

Lady Chapel Walls: Scuff marks on east wall at low level need decoration when the Chapel is next decorated which probably can wait until next quinquennium.

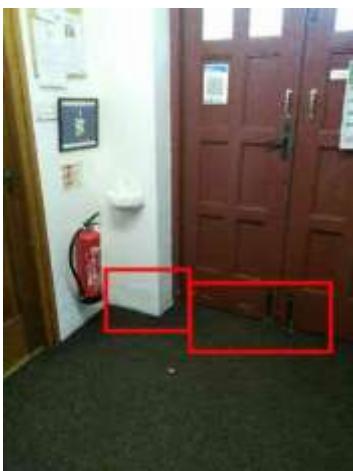
### 2.6.1 Narthex

**Repair Priority:** C - Up to 5 years

**Condition:** Needs Repair

Narthex: Plastered walls and painted paneled ceiling. Entrance mat carpet. There is a crack in plaster noted at low level to west of door. Base of doors will need decorations touching up soon.

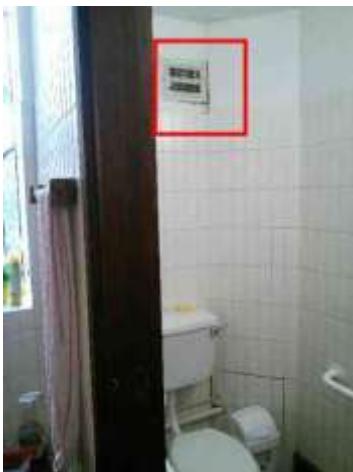
### 2.6.2 Toilet

**Repair Priority:** C - Up to 5 years

**Condition:** Needs Repairs

Toilet off Narthex: Painted plastered walls and ceiling with tiling up most of the height of the walls. Hand basin, cubicle, WC with grab rails, and baby change table. Electric water heater. Sheet vinyl floor. The rusting ventilation grill in toilet needs painting with rust inhibiting paint such as Smooth Hammerite.

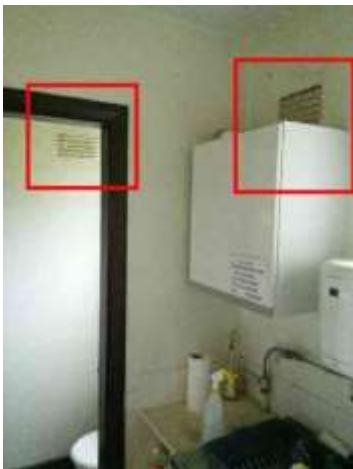
#### 2.6.4 Toilet And Sink Area Off Sacristy

**Repair Priority:** C - Up to 5 years

**Condition:** Needs Repair

Sacristy Toilet and Sink Area: Painted plastered walls and ceiling with splash back tiling . Sink and older kitchen units which may need replacing soon. Electric water heater. Separate toilet cubicle, with WC sheet vinyl floor. The rusting ventilation grills need painting with rust inhibiting paint such as Smooth Hammerite paint. Radiator also needs to be painted.

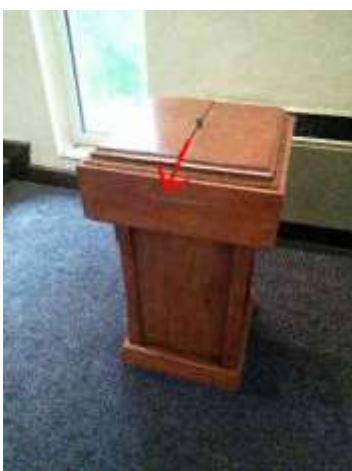
## 2.7.4 Font

The oak Pulpit and oak Dais chairs and benches are generally in good order as is the marble Altar. The Altar inside Chapel is also in good order. There is a modern timber Font to the side of the Dais which has scratch in the varnish on its case which would be good to repair.

**Repair Priority:** B - Up to 2 years

**Condition:** Needs Repair

Timber base to font has a scratch on the varnish which should be repaired.

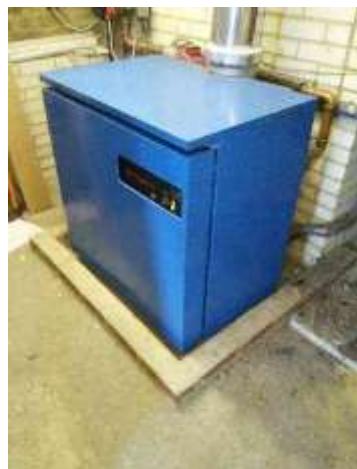
### 3.1.2 Heating (2)

**Condition:** Fair

There is a large, old gas boiler in basement.

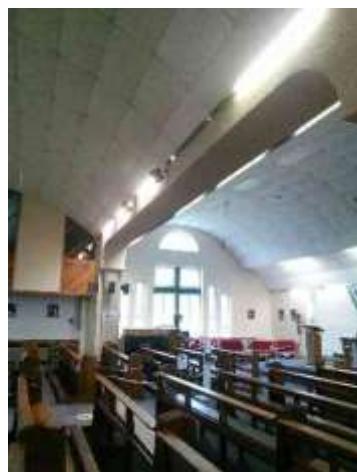
#### 3.2.1 Lighting

The Church interior is well lit with long strips of fluorescent lights and some spotlights. On my visit one fluorescent light was flickering and in need of replacement of its starter. It may be worth considering installing LED strip lights which use less electricity and do not flicker.

**Repair Priority:** D - Desirable Improvements

**Condition:** Reasonable

Fluorescent tube lighting which could be replaced by non-flickering LED strip lights now which would not flicker, cost less to run and need less maintenance.

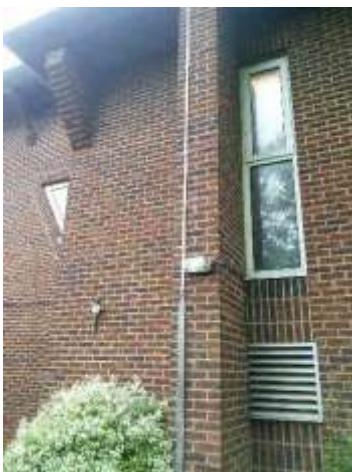
### 3.7.0 Lightning Protection

**Repair Priority:** A - Urgent/ Up to 12 months

**Condition:** Needs Maintenance

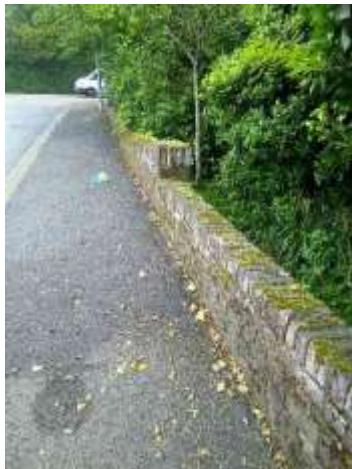
##### 4.1.1 Upper Church Road and Seddlescombe Road Boundaries

**Repair Priority:** C - Up to 5 years

**Condition:** Needs Repair

Boundary Wall to Pavement North & East Sides: Low brick wall with some historical movement noted as it leans slightly in to the Churchyard and there are some old cracks. Missing brick on one pier noted which needs repair.

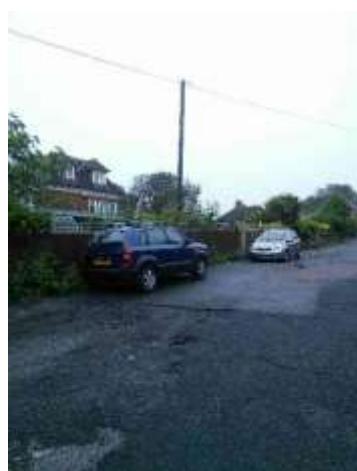
#### 4.1.4 Western Boundary

**Condition:** Fair

Slightly dilapidated neighbouring house fence forms a long western boundary.

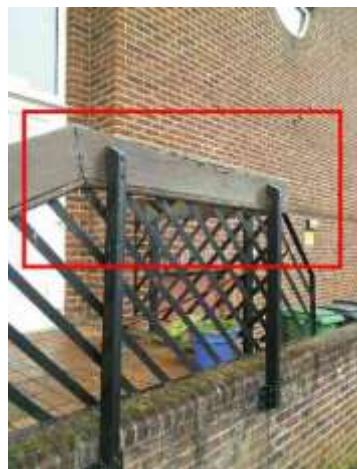
#### 4.2.4 Steps To Back Door

**Repair Priority:** C - Up to 5 years

**Condition:** Needs Repair
