St Thomas of Canterbury and the English Martyrs

Presbytery Inspection 2019

1.00 PRESBYTERY – SUMMARY OF FINDINGS

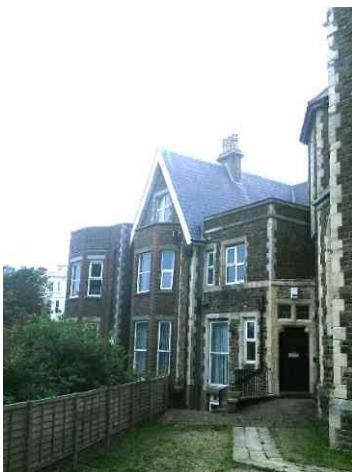
1.1.1 **Roofs Generally**

Condition: Good

The Presbytery has been extensively re-roofed with fibre slates and plastic barge boards. It has flat at second floor level over the lounge and the bathroom with en suite. The roof has three intersecting gables.

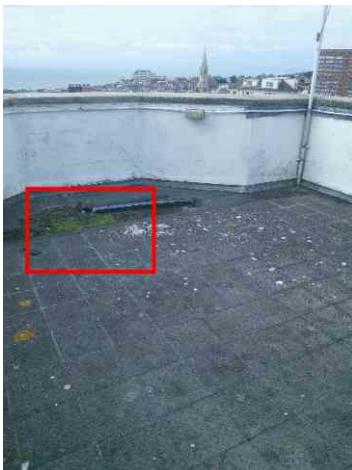
1.1.2 **Flat roof over Father's' Lounge**

Repair Priority: B - Up to 2 years

Condition: Needs Repair

Tiles on felt roof show evidence of some repairs. Sedum plants growing in gutter which need cleaning out. The falls to the deck are minimal and I suspect in heavy rain the water builds up around the chimney and may be making its way into the ceiling by going through the gap between the chimney flashing and the felt roof.

1.1.2	Flat Roof over Lounge: Tiles on felt roof show evidence of some repairs. Sedum plants growing in gutter which need cleaning out. The falls to the deck are minimal and I suspect in heavy rain the water builds up around the chimney and may be making its way into the ceiling by going through the gap between the chimney flashing and the felt roof.	£2000 if still a problem

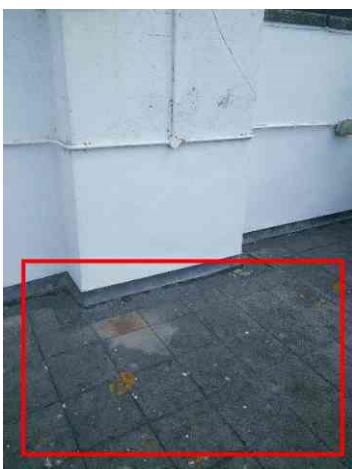
1.1.3 **Area above leaks in Lounge**

Repair Priority: B - Up to 2 years

Condition: Needs Repair

The roof has 'stuck-on' tiling where the leaks have occurred which make it difficult to identify problems.

1.1.3	Leak above Lounge: The roof has stuck-on tiling where the leaks have occurred which make it difficult to identify problems. Ideally, the roof tiles need lifting and the roof re-laid to better falls.

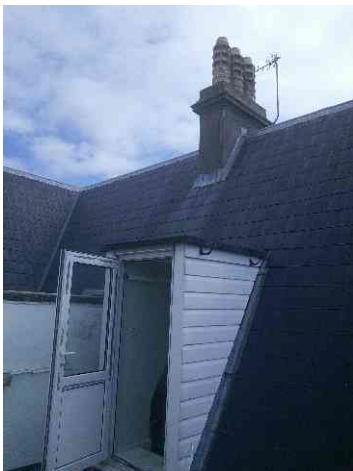
1.1.4 Roof balcony access door

Condition: Reasonable

Flat-roofed dormer doorway gives access to the balcony.

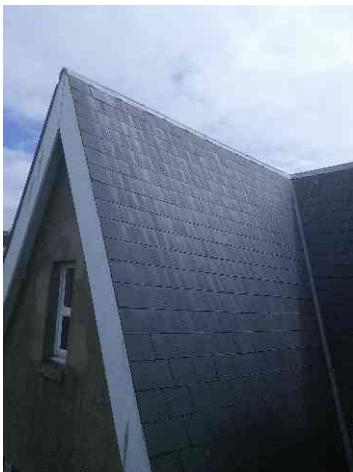
1.1.5 Main roof

Condition: Good

Slate roof with plastic barge-boards.

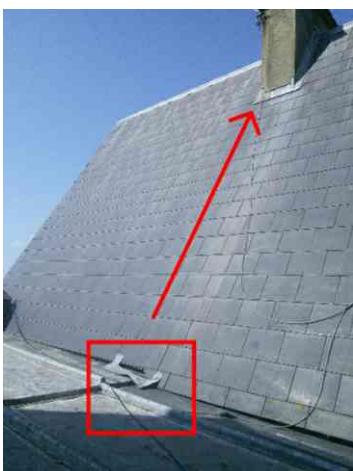
1.1.6 East facing main roof slope

Repair Priority: A - Urgent/ Up to 12 months

Condition: Needs Repair

There is a lead cover flashing which has slipped down from around the chimney. There still seems to be a flashing in place but a roofer needs to investigate and if necessary make repairs. This may be why there are damp marks in the stair ceiling at 2nd floor level.

Item	A: Items which are urgent	Budget Cost
1.1.6	East Facing Main Roof Slope: There is a lead cover flashing which has slipped down from around the chimney. There still seems to be a flashing in place but a roofer needs to investigate and if necessary make repairs. This may be why there are damp marks in the stair ceiling at 2nd floor level.	£200 (it may be already done?)

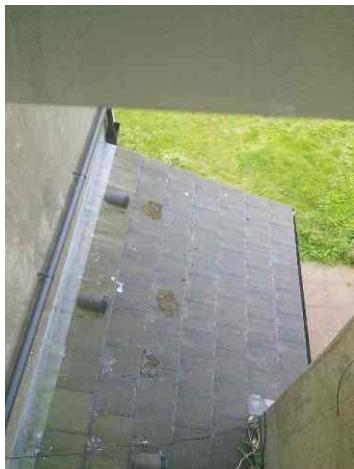
1.1.7 Roof over Fisher Room Toilets

Condition: Good

Shallow slate roof

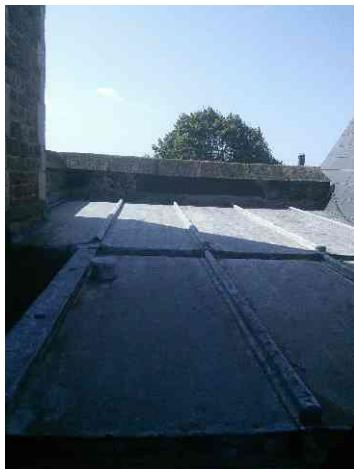
1.1.8 Roof over En-suite

Condition: Reasonable

Shallow lead roof which is generally in good condition.

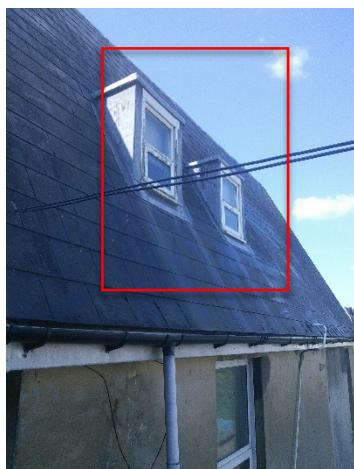
1.1.9 Dormers facing North

Condition: Fair

On the north side of the Presbytery there is a steep artificial slate roof with two dormers in the bathroom. The windows are generally sound but these high up dormers are very dirty.

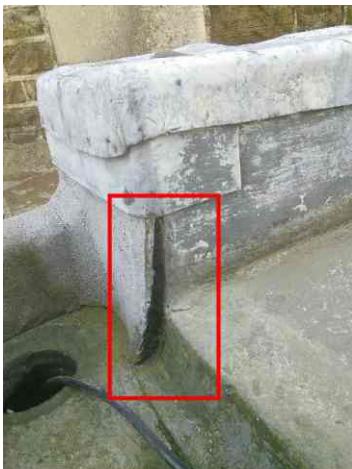
1.1.10 Outlets from Flat Roof over En-suite

Repair Priority: A - Urgent/ Up to 12 months

Condition: Needs Repair

Where the roof over the en-suite behind the Priests' bathroom meets the Church back walls, there is a narrow asphalt roof which has a split and needs repair soon. The water is getting into the structure and affecting the walls in the Sanctuary and the plaster in the en suite below.

1.1.10	Where the roof over the en-suite behind the Priest's bathroom meets the Church back wall, there is a narrow asphalt roof which has a split and needs repair soon. The water is getting into the structure and affecting the walls in the Sanctuary and the plaster in the en-suite below.	£300

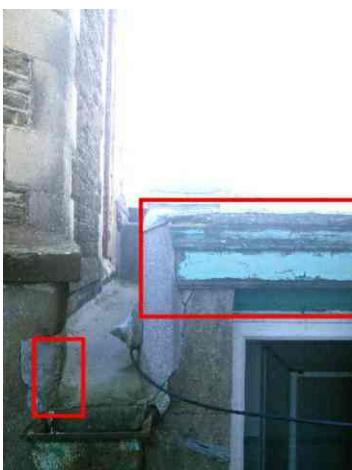
1.1.11 Roof coverings (13)

Repair Priority: A - Urgent/ Up to 12 months

Condition: Needs Repair

The barge-board on the northern side of the flat roof over the en-suite bathrooms, between the vestry and the Church, is rotten and needs replacing. The asphalt gutter to its side is also split vertically and needs a repair (see below).

1.1.11	The barge-board on the northern side of the flat roof over the en-suite bathrooms between the vestry and the Church, is rotten and needs replacing. The asphalt gutter to its side is also split vertically and needs a repair (see below).	£500

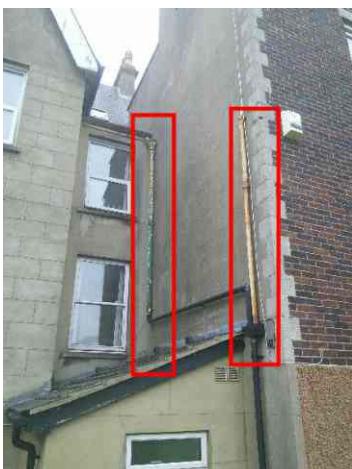
1.2.1 Rainwater goods and disposal systems (1)

Condition: Fair

Mix of cast iron and black plastic gutters and downpipes. The older cast iron ones are in the less accessible locations and generally need of decoration.

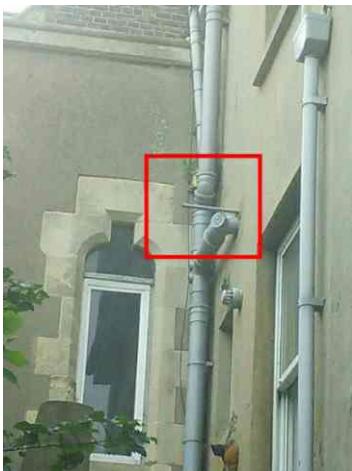
1.2.2 Western downpipe of Sacristy roof

Repair Priority: A - Urgent/ Up to 12 months

Condition: Needs Maintenance

The hopper taking rainwater from the sacristy roof on the west side is blocked and needs clearing

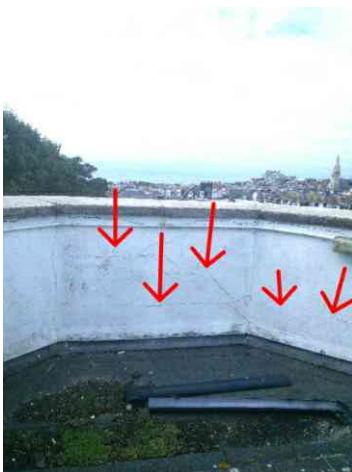
1.3.1 Balcony over Lounge

Repair Priority: C - Up to 5 years

Condition: Needs Repair

There is some cracking to the rendered walls at the back of the balcony parapet walls. This could be due to the failure of the hard render. However, I also suspect that thermal movement is causing some issues around the parapet. There are also dry joints around the coping stones which need filling.

Item	C: Items which have no fixed timescale but should be done in this quinquennium	Budget Cost
1.3.1	There is some cracking to rendered walls at the back of the balcony parapet walls. This could be due to failure of the hard render, but I also suspect that thermal movement is causing some issues around the parapet. There are also dry joints around the coping stones which need filling.	£200+

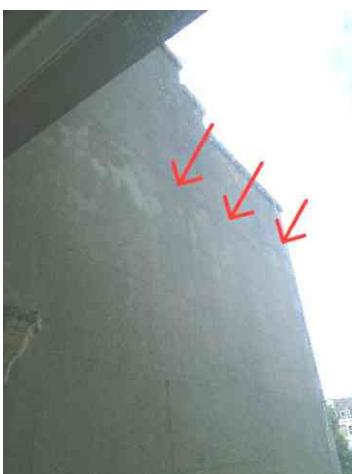
1.3.2 Parapets and upstanding walls, finials, crosses (2)

Repair Priority: O - Keep under observation

Condition: Fair

Externally, there is a line of cracks all-round the west facing balcony. I think this may be due to differential thermal movement between the exposed parapet wall and the walls enclosing the rooms below.

1.3.2	Externally, there is a line of cracks all round the west facing balcony which I think may be due to differential thermal movement between the exposed parapet wall and the walls enclosing rooms below.	See above

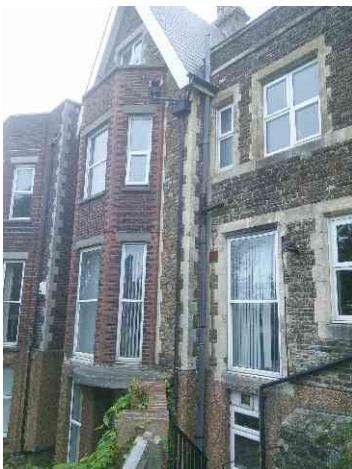
1.4.1 Walling

Condition: Reasonable

The Presbytery has been partially rebuilt and extended over the years. The oldest walls, like the Church, have ironstone walling with Bathstone dressings. The lower ground level is pebble-dashed whilst the higher newer walls and rebuilt bays are in a hard red brick. Generally, in good condition with a few minor defects.

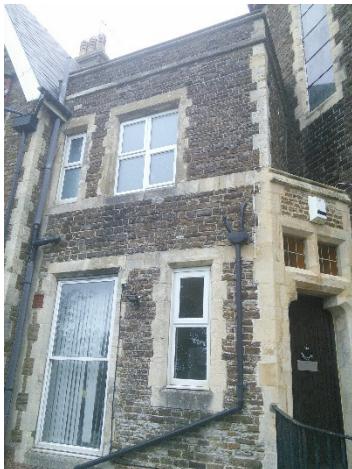
1.4.2 Old stone walls South elevation

Repair Priority: C - Up to 5 years

Condition: Fair

The older stone walls are nearing the point when they need repointing. Some new pointing is evident by the front door. I would recommend sole-patch pointing is done to the south face where there was once a creeper growing up it.

1.4.2	South Elevation: The older stone walls are nearing the point when they need repointing. Some new pointing is evident by the front door. I would recommend sole patch-pointing is done to the south face where there was once a creeper growing up it.	£500

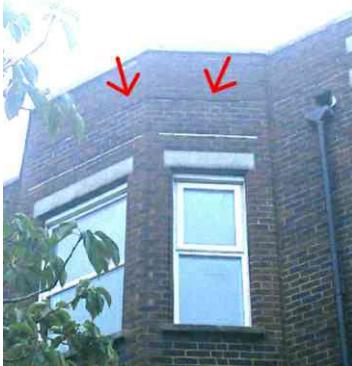
1.4.3 South elevation

Condition: Fair

The pointing is decaying outside the parapet on the west balcony second floor level. See parapets item above. It is likely to need repointing in a couple of quinquenniums.

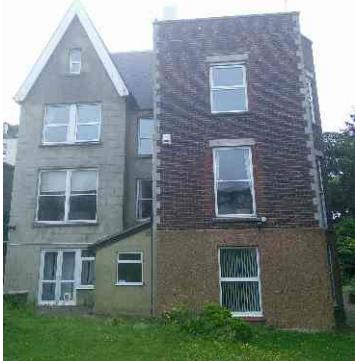
1.4.4 West elevation

Condition: Reasonable

Part brick and part rendered elevation with pebble dash to the John Fisher room. Pointing starting to decay at balcony level.

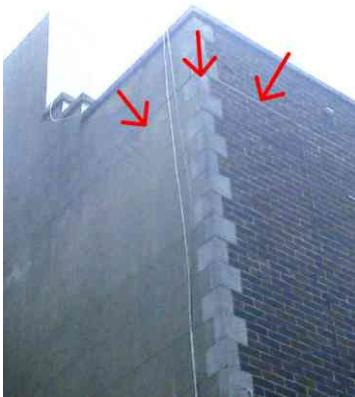
1.4.5 North wall of Father's' Lounge

Cracking noted at balcony level as mentioned above - as noted in 1.3.2 above.

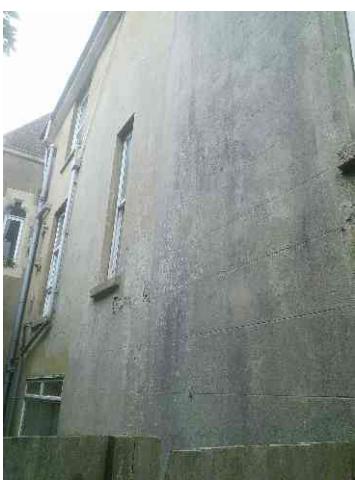
1.4.6 North wall

Condition: Fair

Sheltered older rendered wall. Some spalling of render noted in patches which will need repair in future

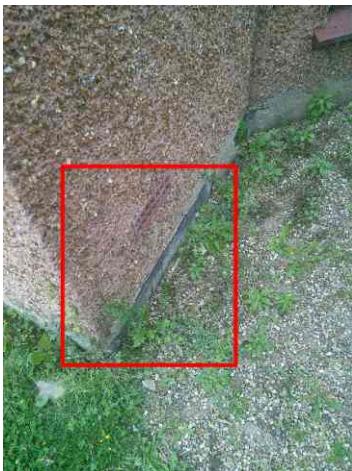
1.4.7 Lower ground South-West corner

Repair Priority: B - Up to 2 years

Condition: Needs Repair

In the south-west corner of the John Fisher room the

external vertical slate dpc is made by vertical slates, possibly protecting a tanking membrane. The slates are coming away from the wall and need fixing back and rendering to stop the damp entering the room.

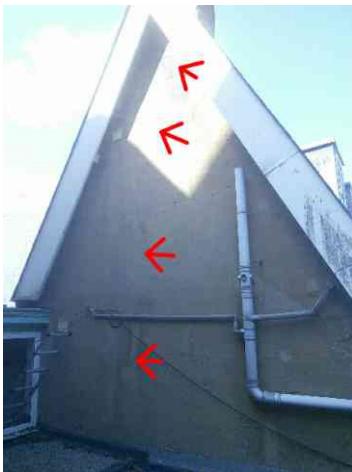
1.4.8 East wall

Repair Priority: O - Keep under observation

Condition: Reasonable

On the eastern gable of the Presbytery there is some

cracking noted. I think is historic but needs to be kept under observation.

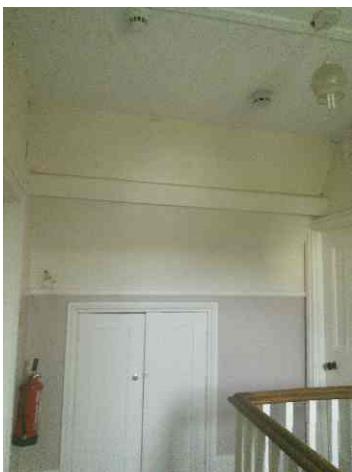
2.1.1 **Top landing**

Condition: Fair

Painted plaster, older carpet, signs of damp on east side of ceiling and on north wall high up. I wonder if this is related to the slipped flashing to the chimney behind.

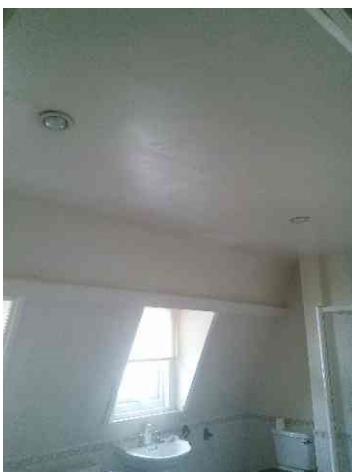
2.1.2 **Top bathroom**

Condition: Fair

Built into roof with painted walls and carpet. WC, shower and bath. The toilet glaze on the porcelain has almost completely worn out in WC trap. If this WC gets used regularly again it will need replacing.

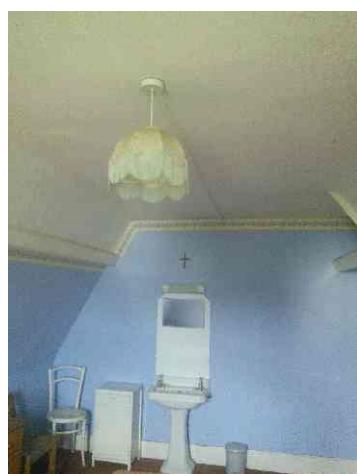
2.1.4 Top West bedroom

Condition: Fair

This room has some cracking to ceiling and an old carpet.

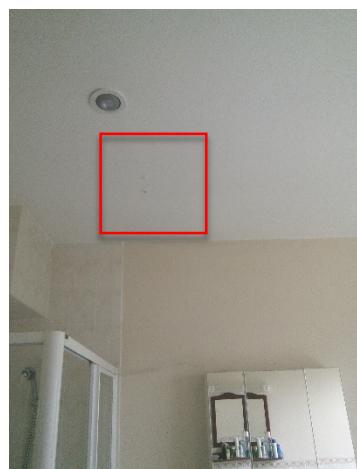
2.1.8 En-suite

Condition: Fair

Bathroom paint starting to peel on ceiling over shower. Part tiled part painted walls, carpet to floor.

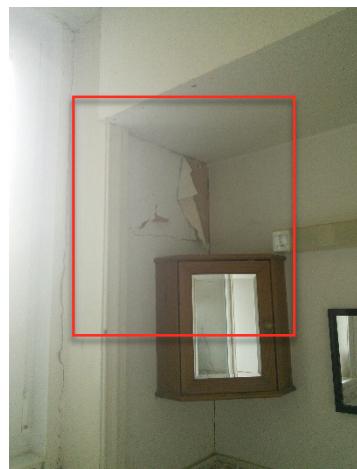
2.1.10 North facing En-suite

Repair Priority: B - Up to 2 years

Condition: Needs Repair

Damp in corner, paint peeling and cracking around window frame. Modern Carlite plaster to walls which is not very tolerant of damp situations. The damp is coming from the hole in the asphalt gutter above and the decayed state of the bargeboard over the window. These need to be repaired soon and then once the wall is dryer the room can be redecorated. See 1.1.10 and 1.1.11 above.

2.1.10	North facing En-suite: Damp in corner, paint peeling cracking around window frame.	£750
	Modern Carlite plaster to walls, which is not very tolerant of damp situations. The damp is coming from the hole in the asphalt gutter above and the decayed state of the bargeboard over the window. These need to be repaired and once the wall is dryer, the room can be redecorated. See 1.1.10 and 1.1.11.

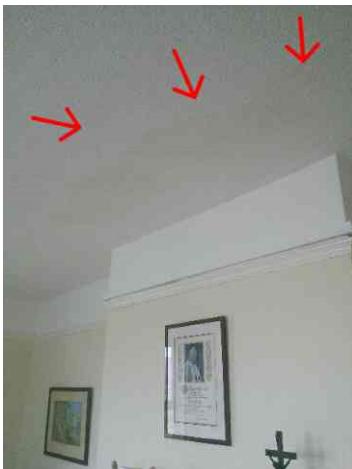
2.1.12 Lounge

Condition: Good

Plastered walls and wall-papered ceiling, carpet on floor but staining on the ceiling by fireplace, from flat roof over. There is no point redecorating until the cause is identified.

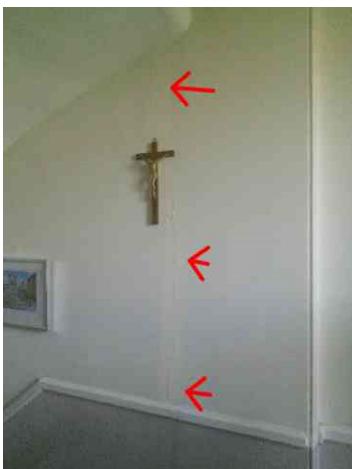
2.1.13 First floor half landing

Repair Priority: D - Desirable Improvements

Condition: Fair

Settlement crack between the two phases of construction which will keep opening up. May be best covered with a painted timber moulding.

Item	D: Items to which improvement is desired	Budget Cost
2.1.13	First Floor Landing: Settlement crack between two phases of construction which will keep opening up. It may be best covered with a painted timber moulding.	£100

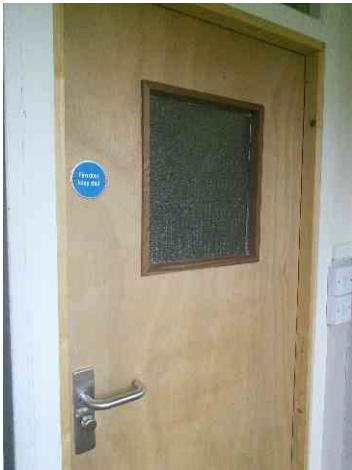
2.1.19 Fire door to basement

Repair Priority: C - Up to 5 years

Condition: Needs Repair

New fire door to basement needs painting, as does the handrail by it. It is perfectly acceptable to paint fire doors.

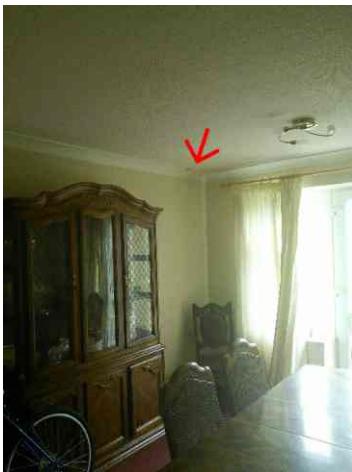
2.1.22 Parish dining room

Repair Priority: M - Routine Maintenance

Papered ceiling and walls, carpet to floor. Paper peeling in south-west ceiling corner - which can

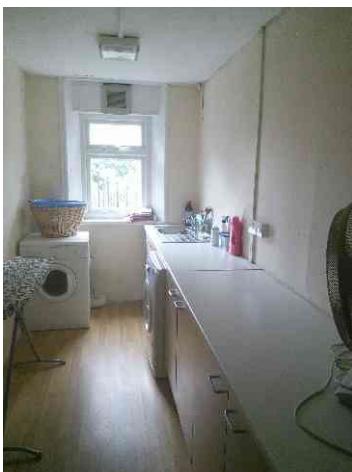
2.1.23 Basement utility room

Condition: Reasonable

Plastered ceiling, rough plastered walls, vinyl flooring, washing machine, tumble dryer and sink. Relatively new units. Door into basement is sticking and needs easing as does door into the utility room.

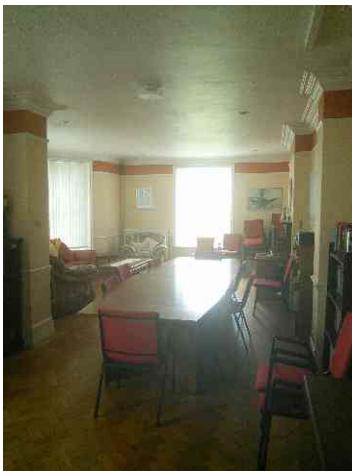
2.1.24 John Fisher room

Condition: Fair

Plastered ceiling with some old cracking, wood chip covered walls, wood block floor, dado rail and cornice. Small refreshments point with sink and kitchen units. Door unpainted and therefore sticking and need easing to stair hall. Unplastered area below worktop unsightly and two steps down into room not ideal. Signs of damp to skirtings on east wall.

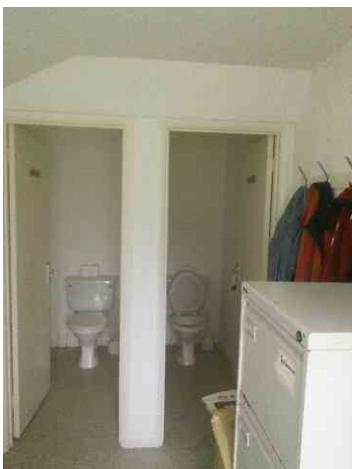
2.1.25 Toilets off John Fisher Room

Condition: Fair

Plastered walls and ceiling, vinyl flooring, two cubicles with a basin outside up two steps from main room. Vinyl lifting by sink and needs sticking down. Rust marks from manhole cover and rusty filing cabinet on the floor.

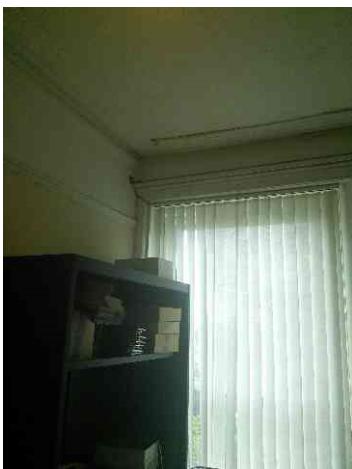
2.1.26 Counting Room

Condition: Reasonable

Plastered ceiling with cracking noted by window

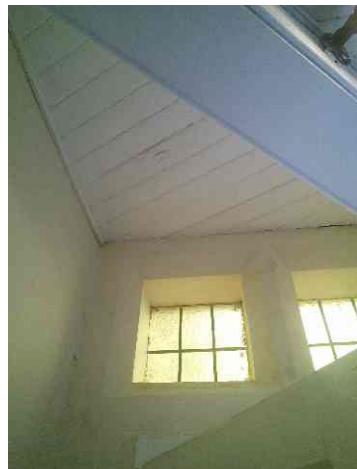
2.1.30 Ceiling to entrance lobby below flat roof

Condition: Fair

Ceiling to entrance lobby below flat roof. Some signs of damp in past which seems to have been dealt with by the recent repairs to the roof over.

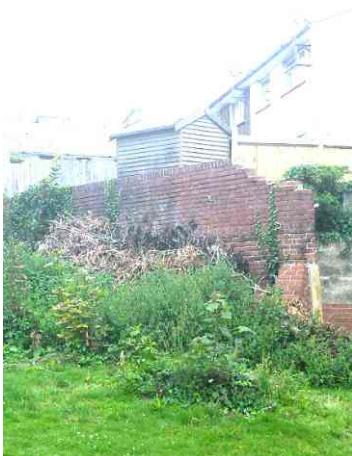
4.1.2 Garden North-East wall

Repair Priority: C - Up to 5 years

Condition: Needs Repair

Significant lean to wall on eastern corner of back garden. It has been buttressed recently, but due to vegetation it is hard to make out condition. Ivy growing up it needs to be removed and it needs pointing.

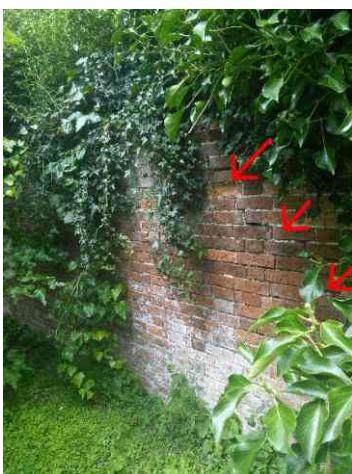
4.1.3 North boundary wall

Repair Priority: B - Up to 2 years

Condition: Needs Repair

Badly leaning with decayed pointing as well as ivy from other side invading. Remove ivy where you can. It has been buttressed in the past, but cracks are showing and some pointing is needed. some evidence of masonry bee attack.

4.1.3	North Boundary Wall: Badly leaning with decayed pointing and ivy invading from the other side. Remove ivy where you can. It has been buttressed in the past but cracks are showing and some pointing is needed. Some evidence of masonry bee attack. This may need engineers advice.	£1000+

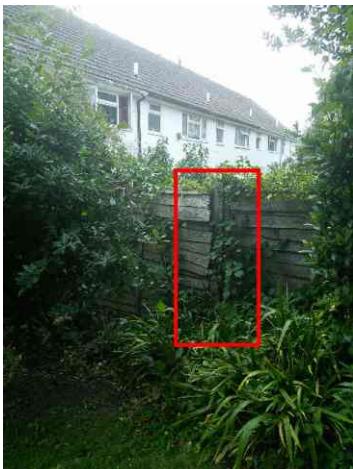
4.1.5 Eastern boundary fence off Presbytery garden

Repair Priority: C - Up to 5 years

Condition: Needs Repair

Wooden fence starting to fail due to ivy on the neighbour's side.

4.1.5	Eastern Boundary fence off Presbytery Garden: Wooden fence starting to fail due to ivy on the neighbour's side.	by Neighbour ?

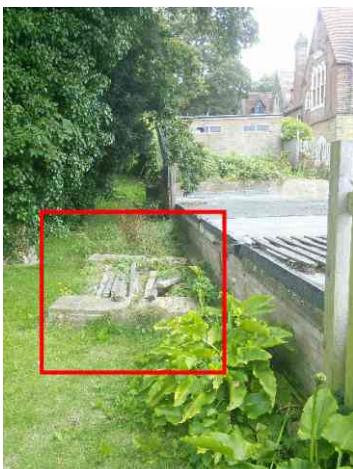
4.1.6 Southern boundary off memorial garden

Repair Priority: C - Up to 5 years

Condition: Needs Repair

Brick piers have fallen over and broken fence. I suggest a lightweight open fence is put back which is less likely to be blown down

4.1.6	Southern Boundary off Memorial Garden: Brick piers have fallen over and broken fence. I suggest a lightweight open fence is put back which is less likely to be blown down	£2500

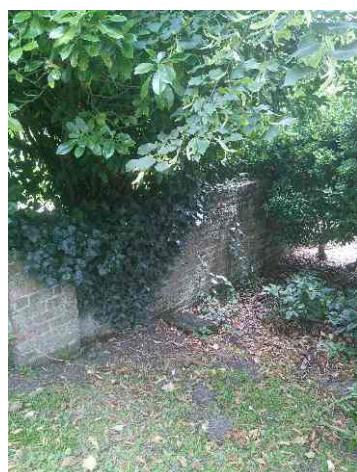
4.2.3 Gardens wall South side

Repair Priority: O - Keep under observation

Condition: Fair

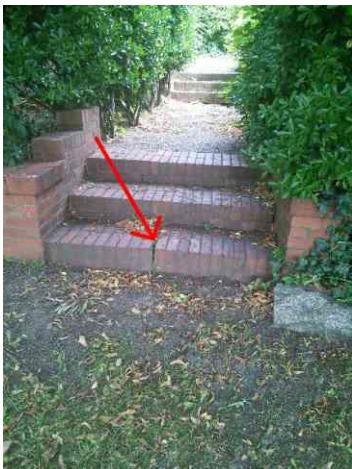
4.2.4 Gardens steps

Condition: Fair

Brick steps on south side with old settlement crack.

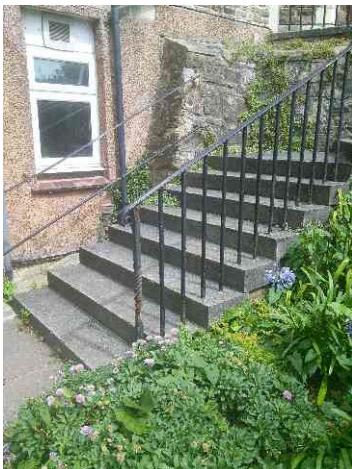
4.2.5 Steps by John Fisher Room

Repair Priority: B - Up to 2 years

Condition: Needs Repair

Rusting barley twist bottom newel will need replacing soon. Hand banisters need decorating towards end of

4.2.5	Steps to John Fisher Room: Rusting barley twist bottom newel which will need replacing soon. Hand banisters need decorating towards end of quinquennium	£750

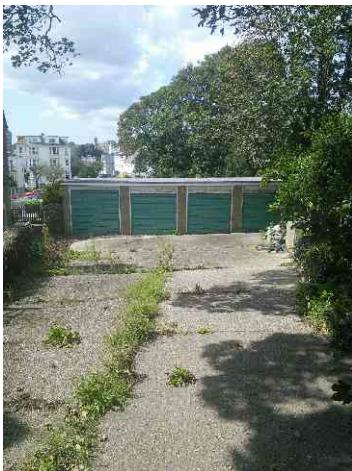
4.2.7 Garages

Repair Priority: M - Routine Maintenance

Condition: Needs Maintenance

I have not inspected inside the garages. They have a felt roof and brick /block walls with metal up and over garage doors. The concrete driveway needs the weeds growing in the cracks killed with a systemic weedkiller.

4.2.7	Garages: I have not inspected inside the garages. They have a felt roof and brick/block walls with metal up and over garage doors. The concrete driveway needs the weeds growing in the cracks killed with a systemic weedkiller.	by church
