# St Thomas of Canterbury and the English Martyrs

## Concordia Hall Inspection 2019

## **1.00 CONCORDIA HALL - SUMMARY OF FINDINGS**

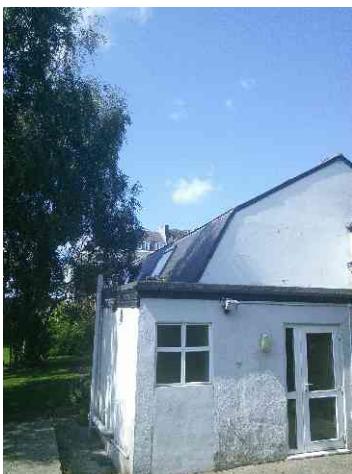
#### 1.1.1 **Roof to Hall**

**Condition:** Reasonable

The Hall has a barrel vault supported on curved girder trusses inside and fibre cement slates coverings Mansard roof outside. At the front there is a flat-roofed two storey wing and to the rear there is a tiled pyramidal roof and a flat section over the stores and toilets. The main roof is in good condition.

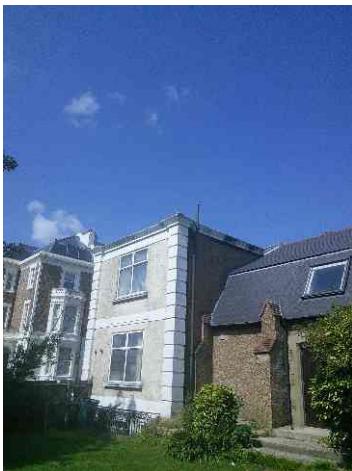
#### 1.1.2 **Roof coverings to front of Hall**

**Repair Priority:** A - Urgent/ Up to 12 months

**Condition:** Needs Repair

I was not able to get up on this roof, but there is clearly a problem of leaks around the roof light to the stairs and some of the lead flashings are lifting on the west side. Crown Roofing did a report in 2018 with photos. They recommended repairs around the roof-light and replacement of the damaged lead parapet, covering with new Code 6 lead weathering. This work is reasonably urgent.

Item	<b>A: Items which are urgent</b>	<b>Budget Cost</b>
1.1.2	Roof over 2 storey section: I was not able to get up on this roof yet but there is clearly a problem with leaks around the roof-light to the stairs and some of the lead flashings are lifting on the west side. Crown Roofing did a report in 2018 with photos. They recommended repairs around the roof-light and replacement of the damaged lead parapet covering with new Code 6 lead weatherings - this is reasonably urgent.	£5000

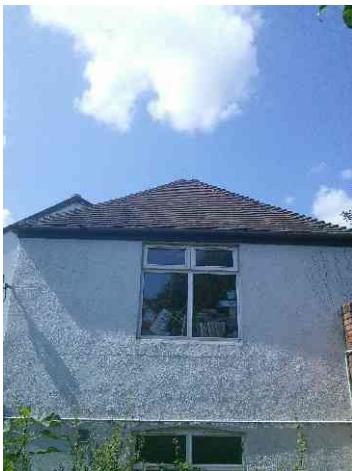
#### 1.1.3 **Refugee Store**

**Condition:** Reasonable

Pyramidal tiled roof with valley gutter against back wall of the Hall.

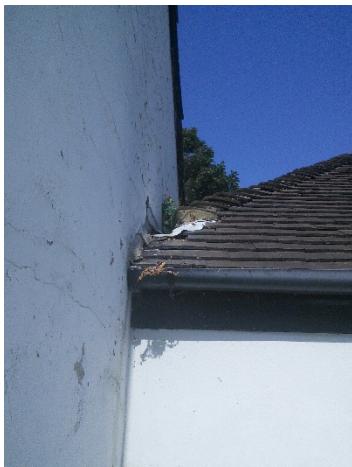
#### 1.1.4 Valley gutter behind Refugee Store roof

**Repair Priority:** M - Routine Maintenance

**Condition:** Needs Maintenance

The gutter behind the Refugee Store roof is blocked and needs cleaning.

<b>Item</b>	<b>M: Items requiring routine maintenance</b>	<b>Budget Cost</b>
1.1.4	The gutter behind the Refugee Store roof is blocked and needs cleaning and check for leaks.	£50
1.2.2	Generally, the gullies need cleaning out around the Hall. The surface water runs via drains into a combined drainage main drain locally.	By Church
1.3.3	Eastern South wall to Toilets: Flaking paint on render noted which could be touched in by a Church working party.	by church
1.3.9	There is ivy starting to grow on the west wall of the rear toilets which should be killed and removed.	By Parish

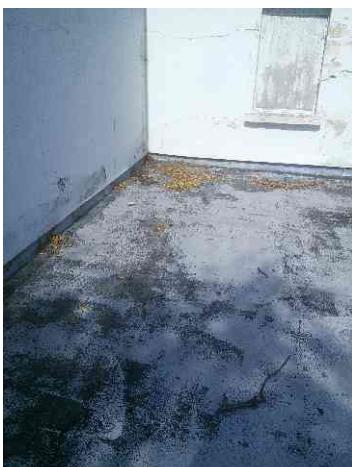
#### 1.1.5 Flat roof over Stores

**Condition:** Reasonable

Flat roof with felt overlay and solar protection.

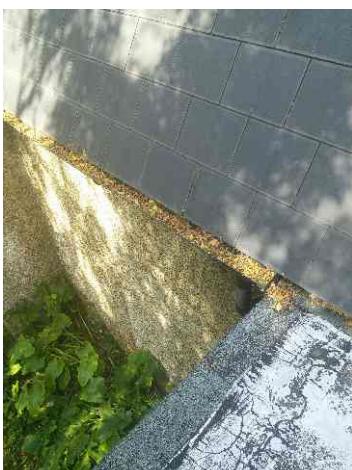
#### 1.2.1 Rainwater Goods

**Condition:** Needs Maintenance

**Repair Priority M:** Routine Maintenance

The gutters and downpipes around the Hall are generally in plastic. They are mostly blocked and need cleaning. Crown Roofing quoted to do this work last year.

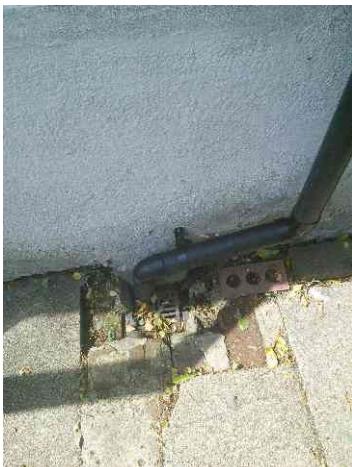
## 1.2.2 Gullies

**Repair Priority:** M - Routine Maintenance

**Condition:** Needs Maintenance

Generally, the gullies need cleaning out around the Hall. The surface water runs via drains into a combined drainage main drain locally.

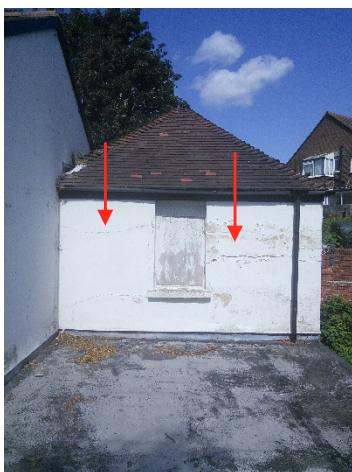
### 1.3.1 Walls to Refugee Store

**Repair Priority:** O - Keep under observation

**Condition:** Fair

There is some minor cracking in the render in a roughly horizontal line around the Refugee Store at first floor level. This could imply some roof spread. Unfortunately, I could not get in the room to confirm my suspicions.

<b>Item</b>	<b>O: Items that should be kept under observation</b>	<b>Budget Cost</b>
1.3.1	There is some minor cracking in render in a roughly horizontal line around the Refugee Store at first floor level. This could imply some roof spread. Unfortunately, I could not get in the room to confirm my suspicions.	Architect to inspect inside store
1.3.4	Some minor cracking noted in east wall of the Hall	
1.3.8	Minor cracking in straight lines noted on east wall of the Hall as noted above.

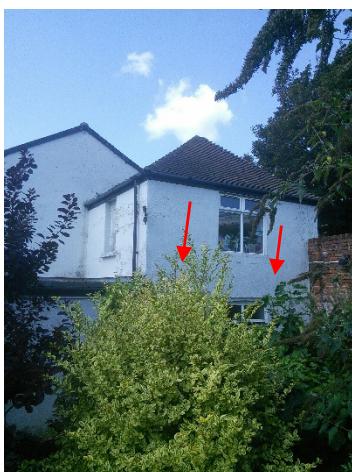
### 1.3.2 Refugee Store south wall

The cracks mentioned above follow round onto the east side as well.

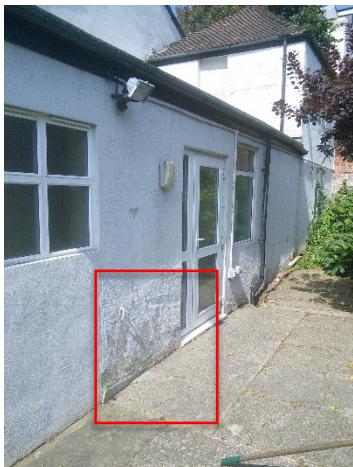
### 1.3.3 Eastern and south wall of Store and Toilets

**Repair Priority:** M - Routine Maintenance

**Condition:** Fair

Flaking paint on render noted, which could be touched in by Church working party.

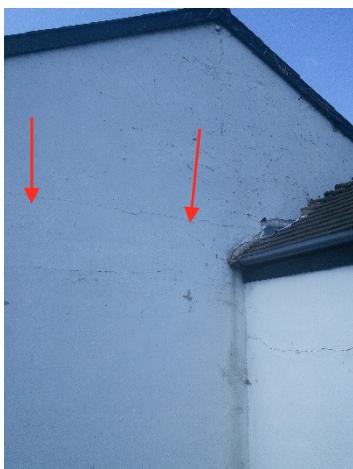
### 1.3.4 East end of Hall

**Repair Priority:** O - Keep under observation

**Condition:** Fair

Some minor cracking noted in east wall of the Hall

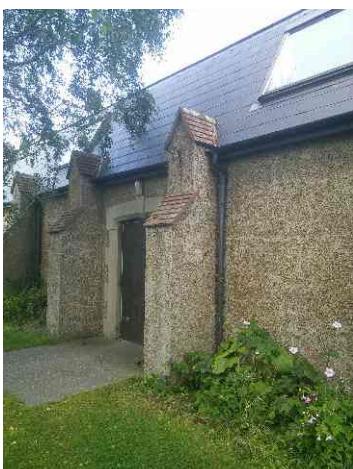
### 1.3.5 Southern Hall wall

**Condition:** Reasonable

Pebble dash wall with some horizontal render cracks noted. Buttresses on the lines of the trusses.

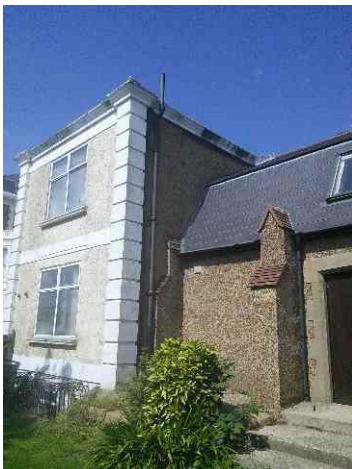
### 1.3.6 Western end

**Condition:** Reasonable

The Hall abuts a two-storey entrance block which has rendered quoins and band course with pebble dash render between.

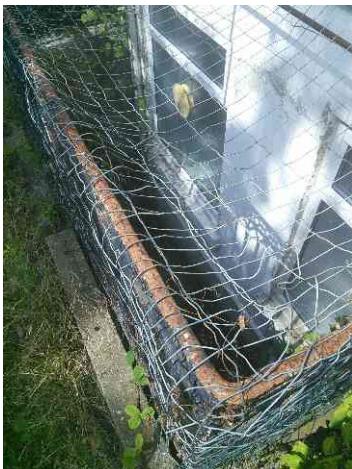
### 1.3.7 Light-well on south side of Female Toilets

**Repair Priority:** D - Desirable Improvements

**Condition:** Fair

The light well on the south side of the Hall, giving light and ventilation to the Female Toilets, is hard to maintain. It has a cast iron railing around it, but children keep posting objects down it. A better cover than the current wire one would be advantageous and make maintenance easier.

1.3.7	The light-well on the south side of the Hall giving light and ventilation to the female toilets, is hard to maintain. It has a cast iron railing around it, but children keep posting objects down it. A better cover than the current wire one would be advantageous and make maintenance easier.	£500

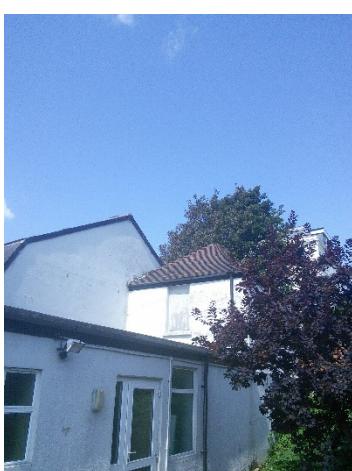
### 1.3.8 East Hall wall

**Repair Priority:** O - Keep under observation

**Condition:** Fair

Rendered wall with minor cracking in straight lines noted on east wall of the Hall, as noted above.

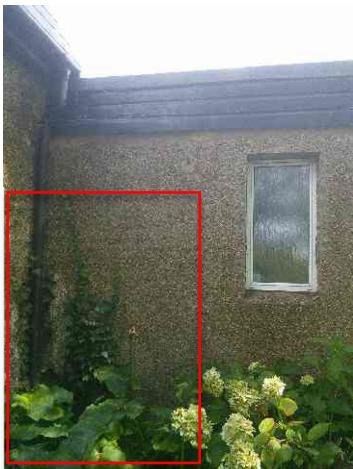
### 1.3.9 West wall of rear Toilets

**Repair Priority:** M - Routine Maintenance

**Condition:** Needs Maintenance

There is ivy starting to grow on the west wall of the rear toilets which should be killed and removed.

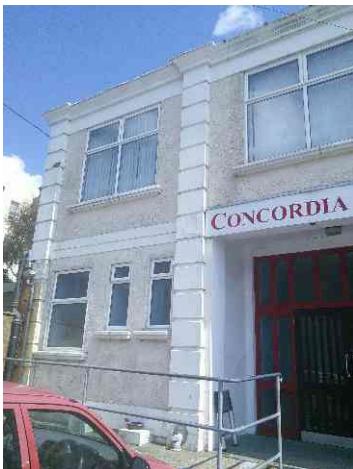
### 1.3.10 Ramp

**Condition:** Reasonable

The Hall has a concrete-ramped access with a simple galvanized hand rail.

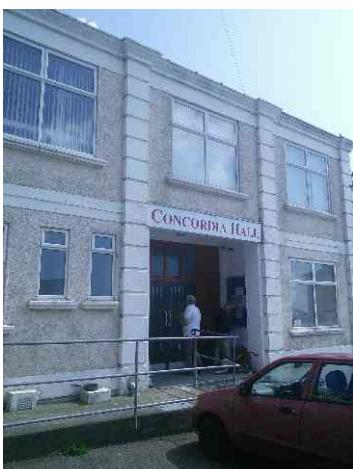
### 1.3.11 West wall of Concordia Hall

**Repair Priority:** C - Up to 5 years

**Condition:** Fair

Painted pebble-dash walls with rendered quoin features and bands. Nearing the point which it needs redecoration.

Item	<b>C: Items which have no fixed timescale but should be done in this quinquennium</b>	<b>Budget Cost</b>
1.3.11	Front West Wall: Painted pebble-dash walls with rendered quoin features and bands. Nearing the point which it needs redecoration.	£1000

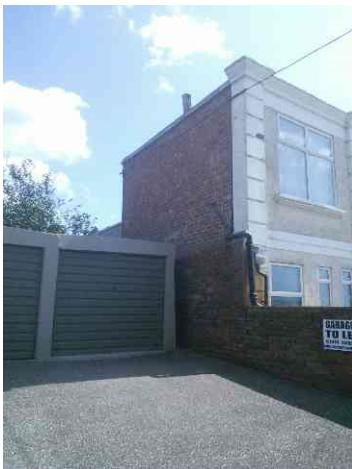
### 1.3.12 North wall

**Condition:** Fair

The Hall is built against a retaining wall on its northern boundary. The two-storey section is in stock bricks.

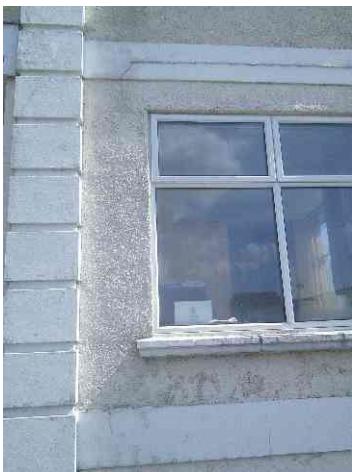
#### 1.4.1 Windows Generally

**Condition:** Good

The Hall generally has slim-line uPVC windows in good working order.

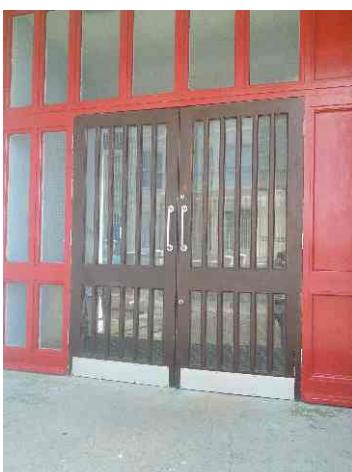
#### 1.4.2 Front Doors

**Condition:** Reasonable

Hardwood doors with recently painted glazed screen.

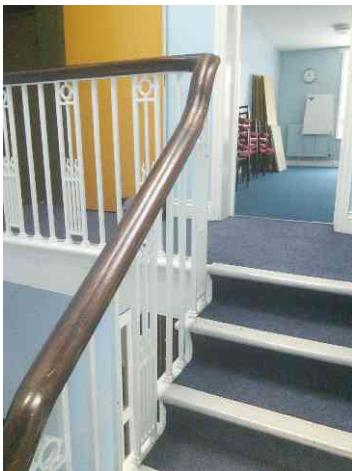
### 2.1.0 **Staircase**

**Condition:** Fair

A solid stair leads up to first floor and down to the basement. It has painted cast-iron banisters and a hardwood hand rail. The walls are marked in places and would benefit from redecoration, as would the ceiling once the leak around the skylight is fixed.

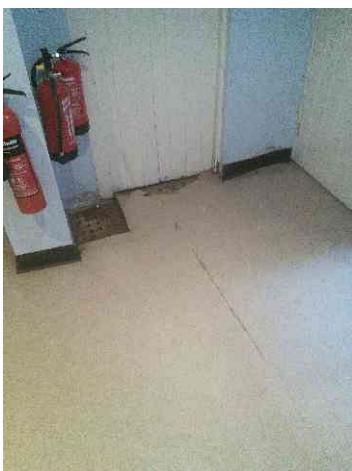
### 2.1.2 **Basement Stair landing**

**Repair Priority:** C - Up to 5 years

**Condition:** Needs Repair

Frayed and cracked sheet vinyl flooring would benefit from replacement.

2.1.2	Basement Stair Landing: Frayed and cracked sheet vinyl flooring would benefit from replacement.	£300

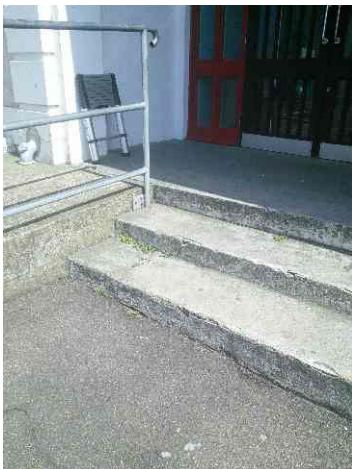
### 2.1.3 External ramp and stairs to Entrance

**Repair Priority:** D - Desirable Improvements

**Condition:** Fair

The treads to the stairs by the Entrance are chipped and could be tidied up and contrasting coloured nosings fitted.

2.1.3	External Steps by Entrance: The treads to the stairs by the entrance are chipped and could be tidied up and contrasting coloured nosings fitted.	£500

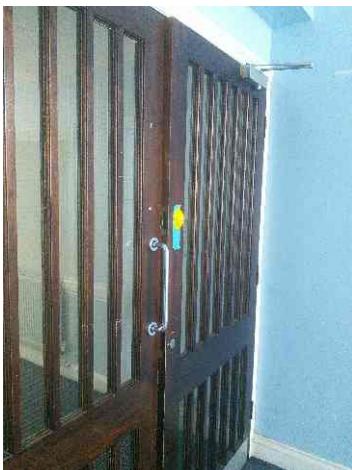
#### 2.2.1 Main Hall Doors

**Repair Priority:** D - Desirable Improvements

**Condition:** Fair

The Hall doors have a strangely yellow coloured pull handle. It would be good to replace it with a matching pull handle as found on the other door leaf.

2.2.1	The Hall doors have a strangely yellow-coloured pull handle and it would be good to replace it with a matching pull handle as found on the other door leaf.	£100

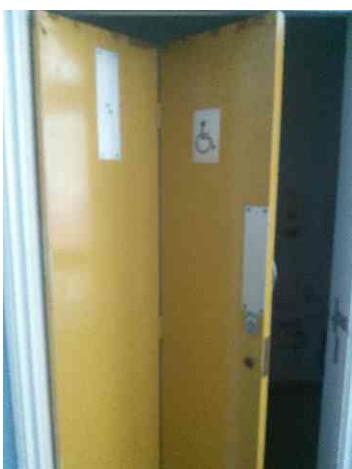
#### 2.2.2 Disabled WC Door

**Repair Priority:** D - Desirable Improvements

**Condition:** Fair

The door to the disabled WC is scuffed and would benefit from redecoration.

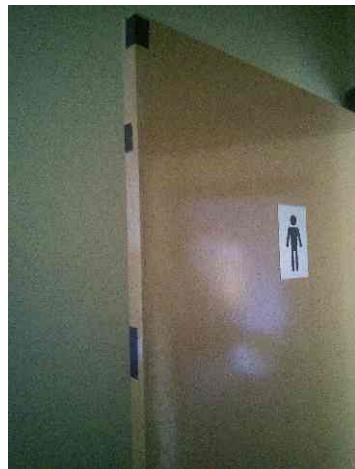
### 2.2.3 West end Male WC Door

**Repair Priority:** M – Routine Maintenance

The door needs the tape removing from its edge where the laminate edging has been glued on.

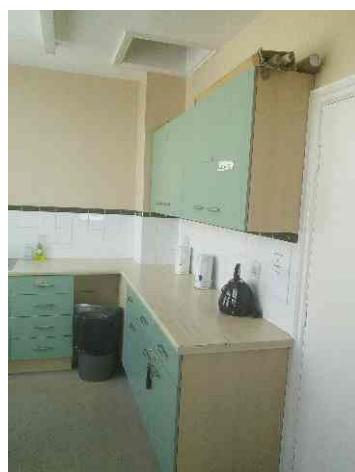
#### 2.3.2 Upper Hall Servery

**Condition:** Reasonable

Relatively modern kitchen server with vinyl flooring. The units are generally ok except for some chips to the laminate worktop edges.

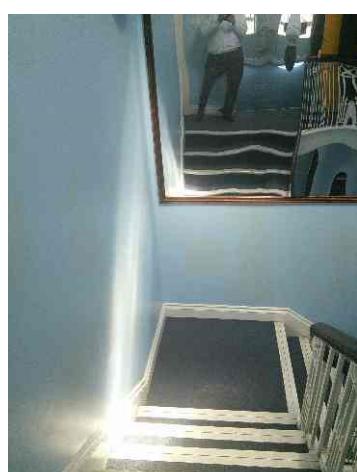
### 2.3.8 Stairs

**Repair Priority:** D - Desirable Improvements

**Condition:** Reasonable

Marks on wall from old posters and patch repairs. Nearing the point when the walls should be redecorated.

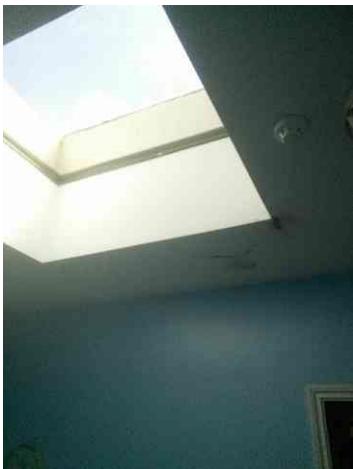
### 2.3.9 Ceiling to Staircase

**Repair Priority:** B - Up to 2 years

**Condition:** Needs Repair

There have been leaks around the roof-light over the stairs. Once these are fixed, the ceiling needs repair.

2.3.9	There have been leaks around the roof-light over the stairs. Once these are fixed the ceiling needs repair.	£see above
2.3.22	Back door lobby: Painted walls and ceiling with vinyl flooring. The stick on skirting is coming off by door as well as signs of cracking screed which need repair.	£200

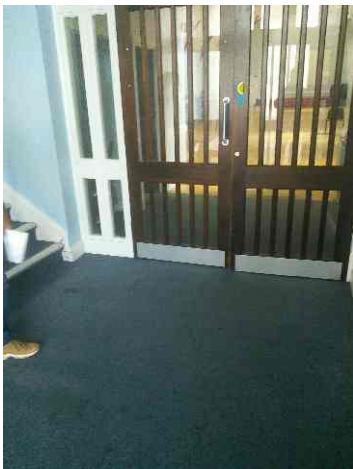
### 2.3.10 Ground Floor Entrance Lobby

**Condition:** Reasonable

Painted ceiling and walls with some scuff marks. Carpet on the floor.

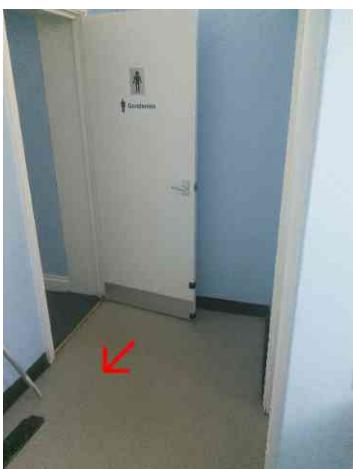
### 2.3.11 Male Toilet

**Repair Priority:** C - Up to 5 years

**Condition:** Needs Repair

The Male Toilet has painted and tiled walls and a painted ceiling. There is non-slip vinyl flooring but as elsewhere is starting to split. At the time of the inspection the Church were re-decorating the room. Two urinals one basin and one WC.

2.3.11	The Male Toilet has painted and tiled walls and a painted ceiling. There is non-slip vinyl flooring which is starting to split. At the time of the inspection the Church was redecorating the room. Two urinals, one basin and one WC.	£500

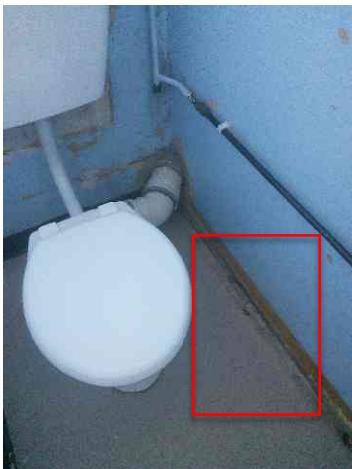
### 2.3.12 Male Toilet Cubicle

The cracked flooring can also be seen in the cubicle in the Male Toilet.

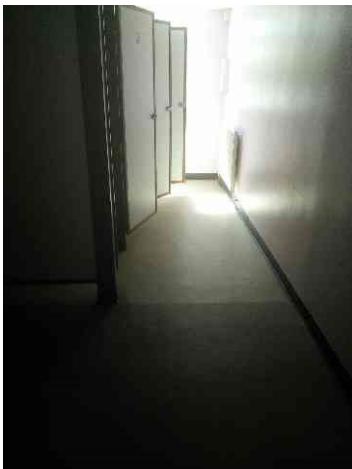
### 2.3.13 Female Toilets

**Repair Priority:** D - Desirable Improvements

**Condition:** Fair

Painted walls and ceiling. Toilets in cubicles. The vinyl sheet flooring shows signs of wear and cracking of floor screed below. End wall by light-well is damp and the vanity unit looks tired.

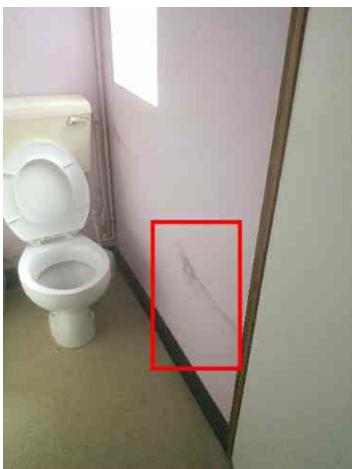
### 2.3.14 Toilet wall South Female

Damp coming through dry lining and at base of rear toilet wall.

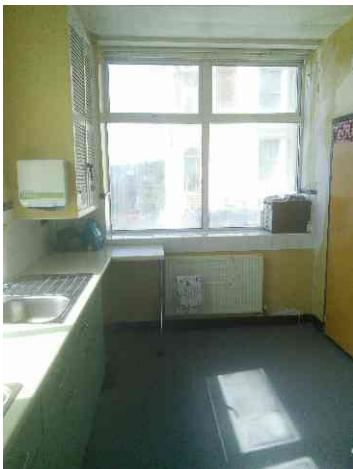
### 2.3.15 Kitchen

**Repair Priority:** D - Desirable Improvements

**Condition:** Fair

Damp low down on dry-lined walls. Old kitchen units in need of replacement. Cracked laminate non-slip vinyl which is bubbling in the opening to the Servery double sink and hand wash.

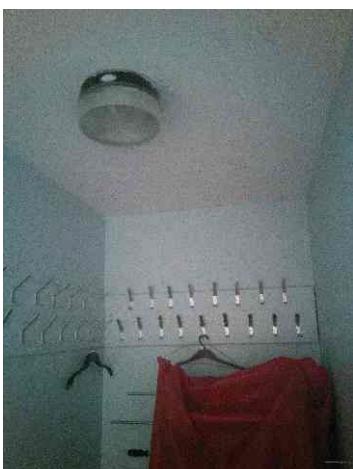
### 2.3.17 Cloak cupboard

**Repair Priority:** D - Desirable Improvements

**Condition:** Reasonable

Painted walls and ceiling. Coat hooks line the walls and there is carpet on the floor. The paint on light fittings needs cleaning off.

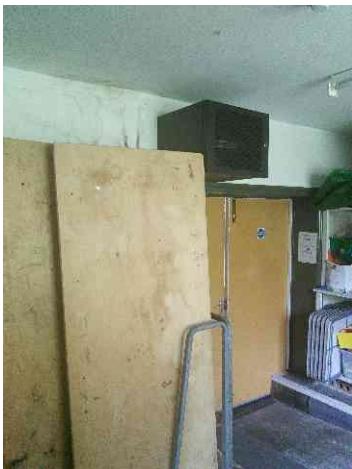
### 2.3.18 Table Store

**Repair Priority:** C - Up to 5 years

**Condition:** Needs Maintenance

Damp on wall high up, carpet tiles off to inside of the ramp. Plasterwork scuffed and soiled. The room would benefit from wall protection being put round it in the form of timber wall guards.

2.3.18	Table Store: Damp on wall high up, carpet tiles off to inside of the ramp. Plasterwork scuffed and soiled. The room would benefit from protection being put round it in the form of timber wall guards.	By Church?

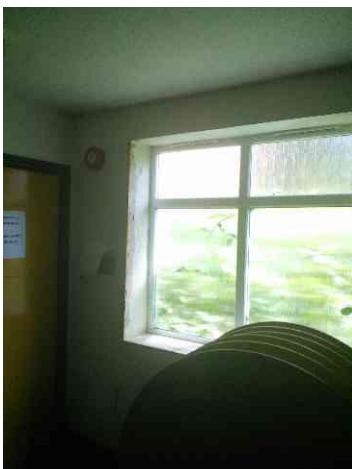
### 2.3.19 Table Store window reveals

**Repair Priority:** C - Up to 5 years

**Condition:** Needs Repair

Damp is coming through and blowing the plaster around the window. The window has been plastered in the past with a modern Gypsum and cement plaster, which suffers in damp conditions. It may be better to re-plaster in a lime plaster and use a breathable.

2.3.19	Table Store Window Reveals: Damp is coming through and blowing the plaster around the window. The window has been plastered in the past with a modern Gypsum and cement plaster which suffers in damp conditions. It may be better re-plastering in a lime plaster.	£500

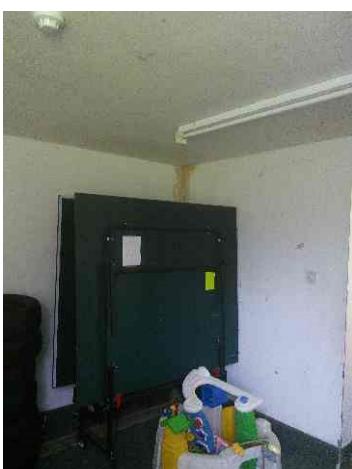
### 2.3.20 Chair Store

**Repair Priority:** C - Up to 5 years

**Condition:** Needs Repair

Like the Table Store, it has a painted textured ceiling and the walls are plastered and heavily dented and scuffed. The floor has an old soiled carpet. There has been a leak in north-west corner.

2.3.20	Chair Store: Like the Table Store, the ceiling is a painted textured ceiling and the walls are plastered and heavily dented and scuffed. The floor has an old soiled carpet. There has been a leak in north-west corner.	By church

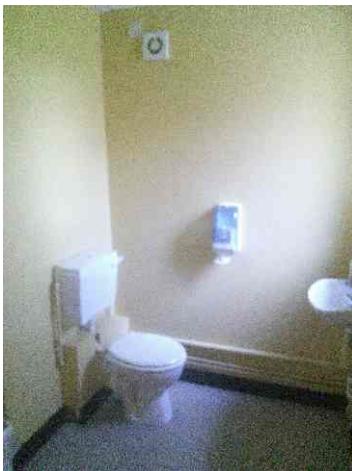
### 2.3.21 Toilet Male west end

**Condition:** Fair

Sheet non-slip vinyl, painted walls and ceiling. Hair-line crack on dry-lined plaster south wall.

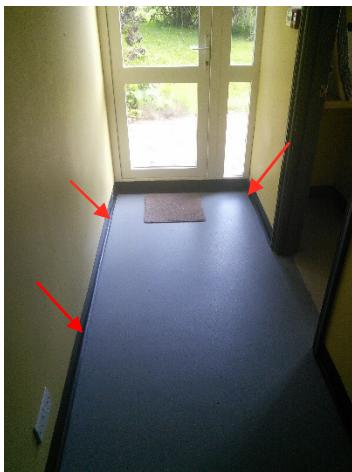
### 2.3.22 Back Door Lobby

**Repair Priority:** B - Up to 2 years

**Condition:** Needs Repair

Painted walls and ceiling, with vinyl flooring. The stick on the skirting is coming off by door. There are also signs of cracking screed below the vinyl flooring.

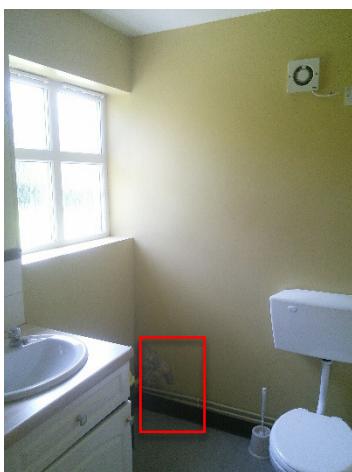
### 2.3.23 West end Female Toilet

**Repair Priority:** B - Up to 2 years

**Condition:** Needs Repair

Painted ceiling and walls. Tiled splash-back over basin. Older vanity unit. Sheet vinyl flooring. Damp low down

coming through the wall in the south-east corner. This is probably due to the condition of the

2.3.23	West end Female Toilet: Painted ceiling and walls with tiled splash-back over basin. Older vanity unit. Sheet vinyl flooring. Damp low down coming through wall in south-east corner, probably due to condition of rainwater pipe.	by Church

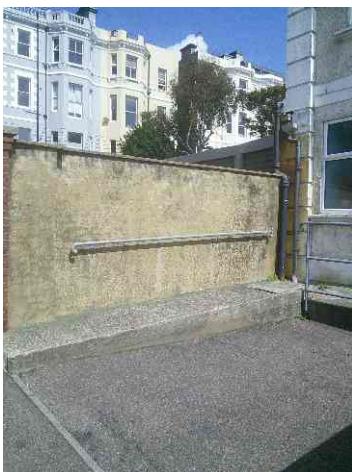
#### 4.1.1 Northern Boundary

**Condition:** Fair

Rendered brick retaining wall by ramp to entrance.

Elsewhere along this boundary, the Hall is built up against the old retaining boundary walls.

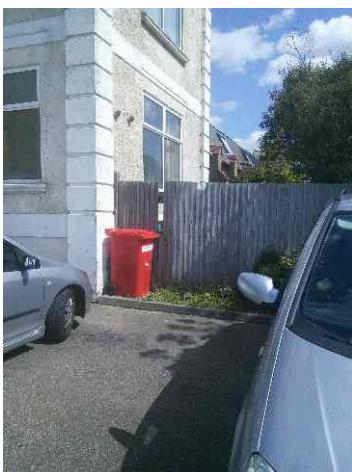
#### 4.1.2 Western Boundary

**Repair Priority:** C - Up to 5 years

**Condition:** Needs Repair

Close-boarded fence in need of repair. The door gets forced open at times and needs better locks to control it.

4.1.2	Western Boundary: Close-boarded fence in need of repair. The door gets forced open at times and needs better locks to control it.	£200
Item	<b>D: Items to which improvement is desired</b>	<b>Budget Cost</b>
