QUINQUENNIAL INSPECTION REPORT 2019

Location, Dedication	:	The Church of St Thomas of Canterbury & English Martyrs
Parish	:	The Parish of St Leonards-on-sea

Report Prepared by:
Nicholas Lee Evans
Lee Evans Partnership LLP
St Johns Lane
Canterbury
Kent CT1 2QQ

Inspection : August 2019

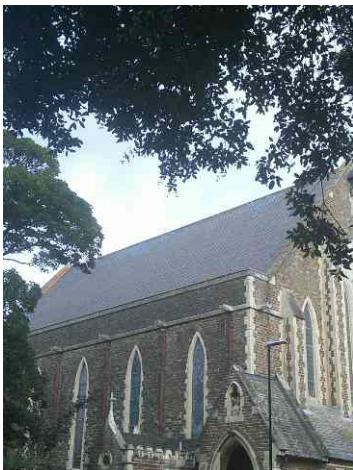
1.1.1 **Main Roof**

Condition: Reasonable

The Church has a steep pitched slate roof over the main body of the Church, covered in natural slates with clay ridge tiles and small gables at each end with tile-covered flaunching. On each side there is a lead-covered flat roof over the side chapels with 7 outlets and overflows. These flat roofs need regular cleaning at least once a year, but access is difficult. A cat ladder could be fitted from the Presbytery roof to the northern valley, but there is no easy route to the southern roof.

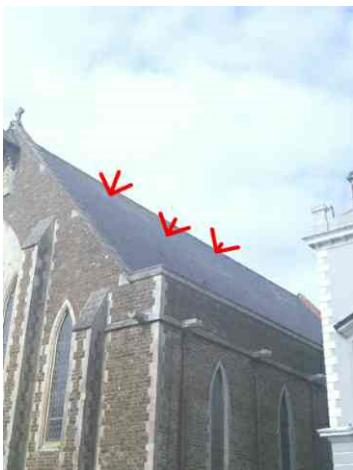
1.1.2 **North Slope of Main Church Roof**

Repair Priority: B - Up to 2 years

Condition: Needs Repair

The north slope of the main roof has a number of slates fixed with copper and lead to tingles (little metal strips) and has half a dozen slipped tiles which need fixing. The north-west flaunching above the chancel arch may need some attention as the paintings are deteriorating below the weathering stones low down. I understand there is an old cable in this location which may be part of the problem.

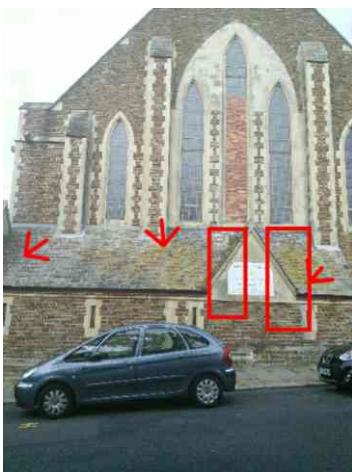
1.1.4 Narthex Roof

Repair Priority: B - Up to 2 years

Condition: Needs Maintenance

The narthex has a Welsh slate roof pitched off the main Church with a stone roof below the slates. There are a number of cracked slates and a couple of slipped slates which need repair. Moss and bird droppings is building up against the northern gable and should be removed before it damages the slates.

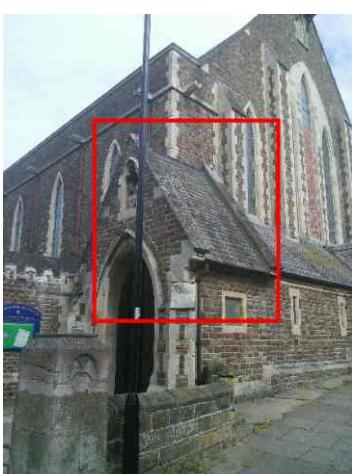
1.1.5 Porch Roof

Condition: Reasonable

The porch roof stands above the narthex roof, with Welsh slate coverings to road side and modern slates to the western side. Low gables rise at each end with cement flaunching between the parapet walls and the roof.

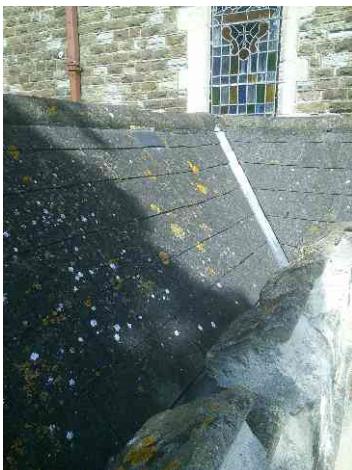
1.1.7 Lead gutter around Toilets off Narthex

Repair Priority: M - Routine Maintenance

Condition: Needs Maintenance

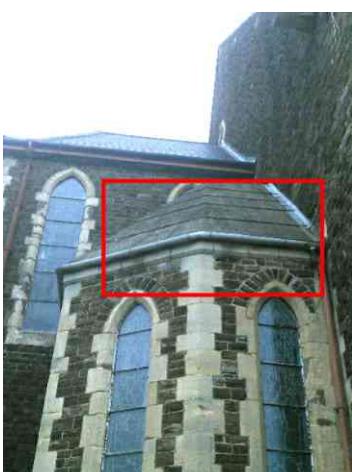
1.1.9 West End South Chapel

Condition: Reasonable

Stone clad roof - some chipping noted on leading edges. The stone must be letting in some water given the condition of the decorations below. In the long term it may be good to clad with slates.

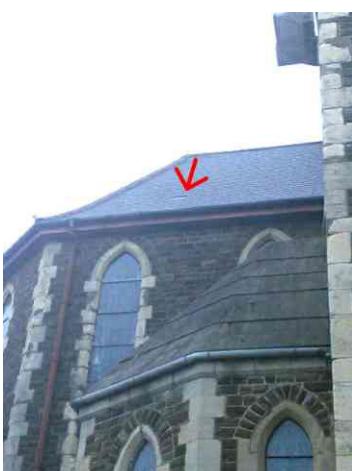
1.1.10 Chancel Roof

Repair Priority: B - Up to 2 years

Condition: Needs Repair

The chancel roof is a relatively modern apsidal slate roof with slipped tile on south side. Clay ridge tiles in good condition.

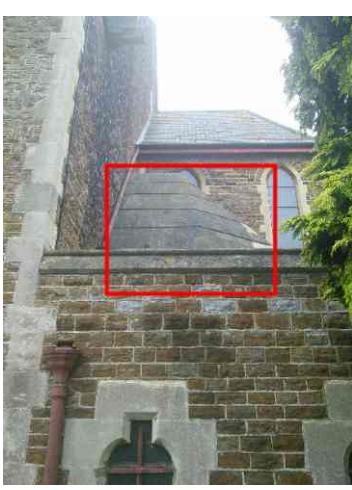
1.1.13 West End Northern Chapel Roof

Condition: Good

Stone faced apsidal roof with a loose gutter against the

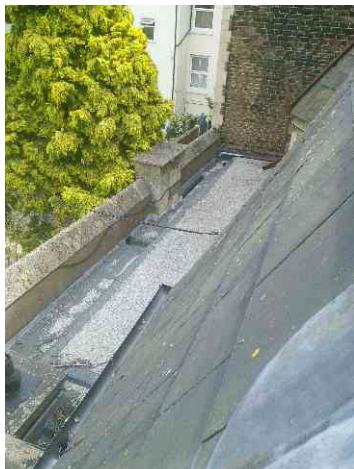
1.1.14 Sacristy Roof

Condition: Reasonable

New felt roof over what I assume was an old asphalt roof.

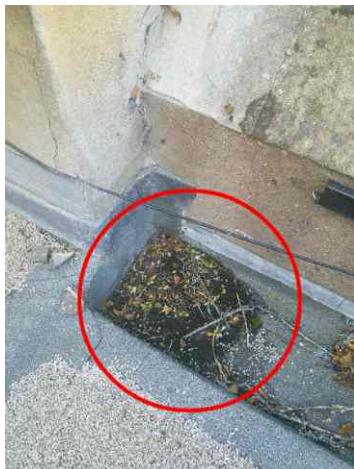
1.1.15 Outlet from Sacristy Roof facing East

Repair Priority: M - Routine Maintenance

Condition: Needs Maintenance

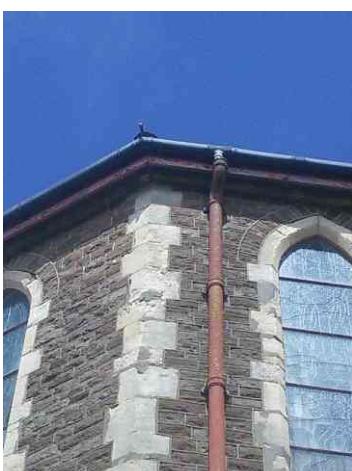
1.2.10 Chancel Gutter

Repair Priority: C - Up to 5 years

Condition: Needs Repair

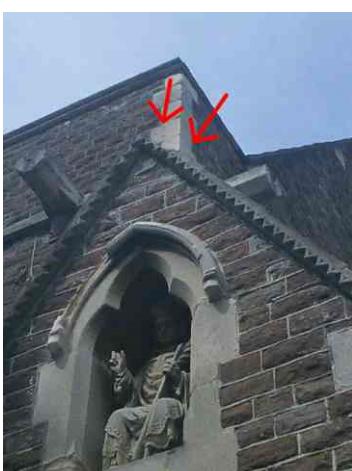
1.3.1 South Porch Finial

Repair Priority: C - Up to 5 years

Condition: Needs Repair

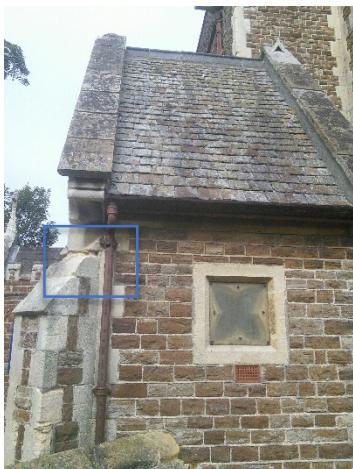
1.3.5 South Porch Parapet

Repair Priority: C - Up to 5 years

Condition: Needs Repair

The base kneeler stone at the bottom of the western parapet wall over the south porch has laminated and needs repair.

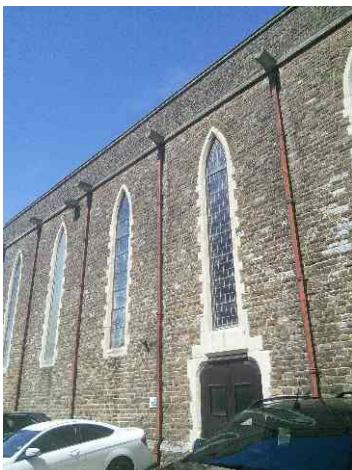
1.4.4 Southern Wall

Condition: Needs Repair

Superficially the south wall looks to be in reasonable condition, but unlike the east wall, it has been repointed with a cementitious raised pointing over the lime pointing behind. I think the hard ironstone will be relatively impermeable. As mentioned above, when this wall gets soaked it will lead to moisture being trapped by the hard stone and the raised impermeable cement pointing. This will force the wall to dry inwards damaging the painted plaster walls.

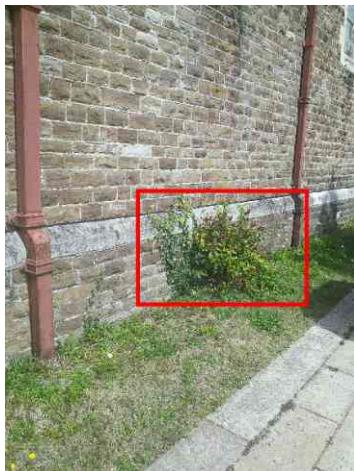
1.4.6 Ivy on Southern Wall

Repair Priority: M - Routine Maintenance

Condition: Needs Maintenance

Ivy needs to be killed off on the south wall

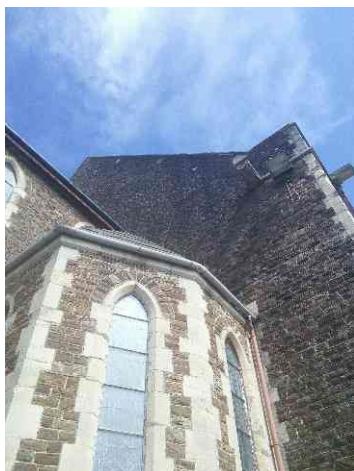
1.4.7 West Wall of Nave

Repair Priority: C - Up to 5 years

Condition: Needs Repair

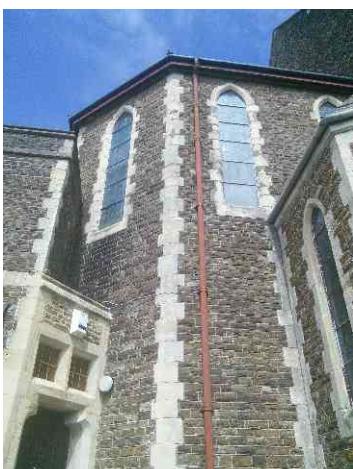
1.4.10 Chancel Walls

Repair Priority: C - Up to 5 years

Condition: Needs Repair

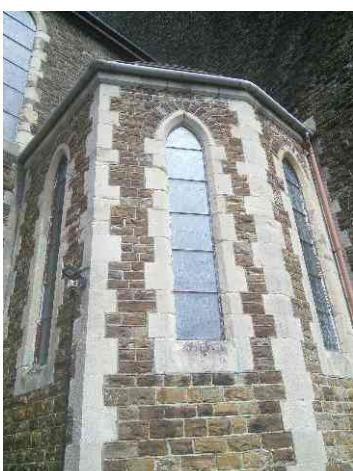
1.4.11 Southern Chapel at West End

Condition: Fair

Some remnants of ribbon pointing on southern chapel at west end noted.

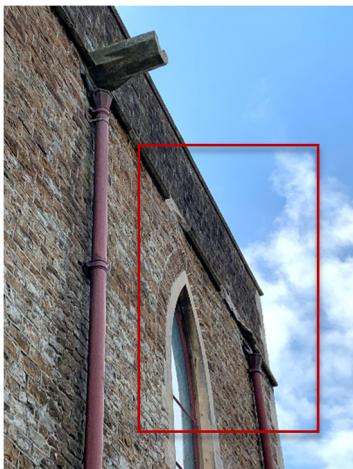
1.4.15 North Wall

Repair Priority: B – Up to 2 years

Condition: Needs Repair

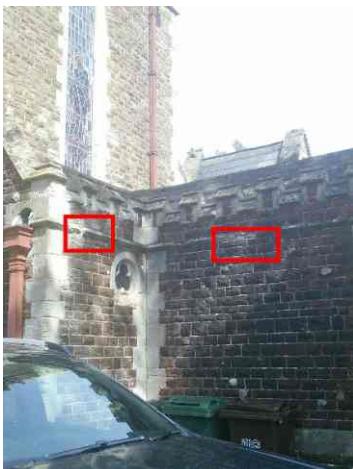
1.4.16 West Side of Toilets

Repair Priority: C - Up to 5 years

Condition: Needs Repair

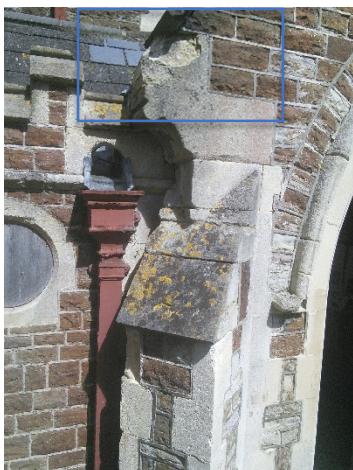
1.4.17 Western Porch Buttress

Condition: Needs Repair

In addition to the decay on the kneeler stone at the base of the porch parapet, a quoin against the rainwater pipe has decayed and requires repair.

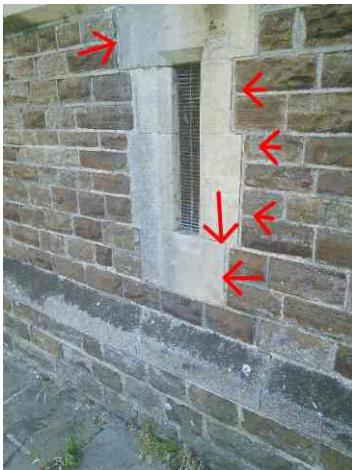
1.5.2 Narthex Windows

Repair Priority: C - Up to 5 years

Condition: Needs Repair

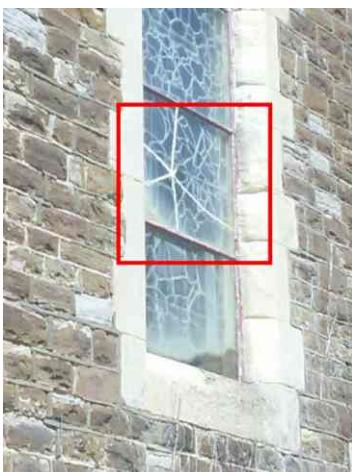
1.5.5 Second Window from East End South Elevation

Repair Priority: D - Desirable Improvements

Condition: Needs Repair

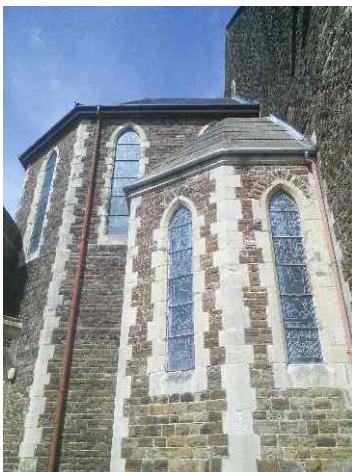
1.5.6 Chancel Window

Some cracking to secondary glazing noted to south chancel chapel and chancel windows.

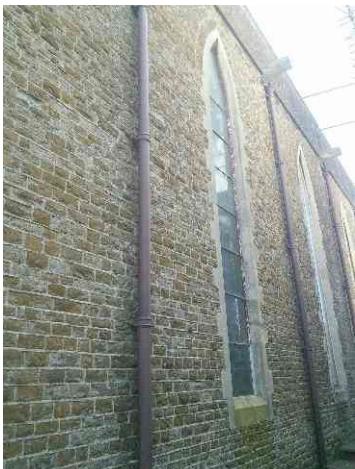
1.5.7 Northern Windows

Condition: Fair

Lancet windows with either polycarbonate or glass secondary glazing. Some plants growing behind secondary glazing causing condensation to build up.

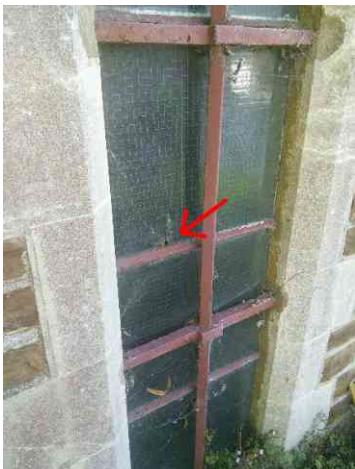
1.5.8 North Sacristy Windows second from West

Repair Priority: D - Desirable Improvements

Condition: Needs Repair

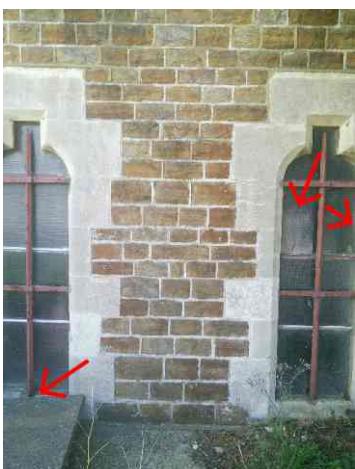
1.5.9 Eastern Sacristy Windows

Repair Priority: C - Up to 5 years

Condition: Needs Repair

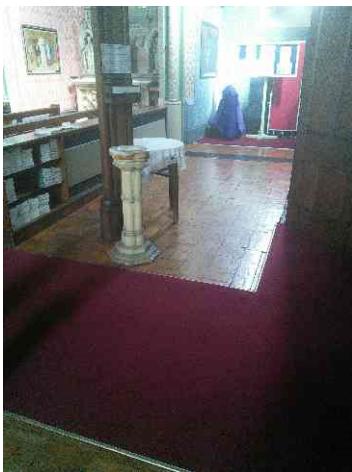
2.6.1 Nave and Side Chapel Floors

Condition: Needs Repair

Wooden block floor with carpeted central passageway and side chapels. Cast iron gratings to side passages and hidden below carpet to the centre. There are a number of loose wooden blocks adjacent to grilles.

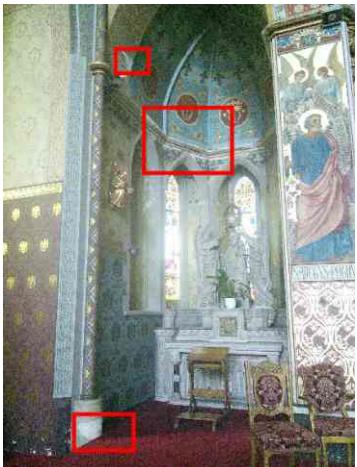
2.7.2 Our Lady Chapel

Repair Priority: C - Up to 5 years

Condition: Needs Repair

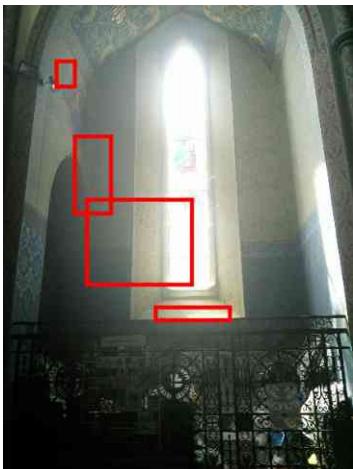
2.7.3 The Repository

Repair Priority: C - Up to 5 years

Condition: Needs Repair

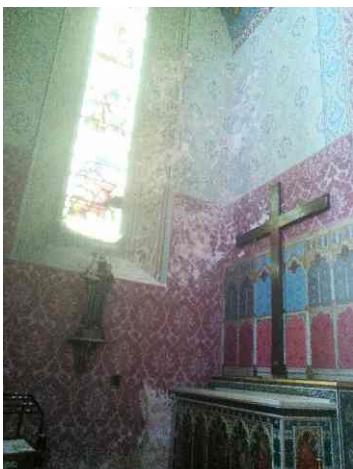
2.7.4 St Anthony's Chapel

Repair Priority: C - Up to 5 years

Condition: Needs Repair

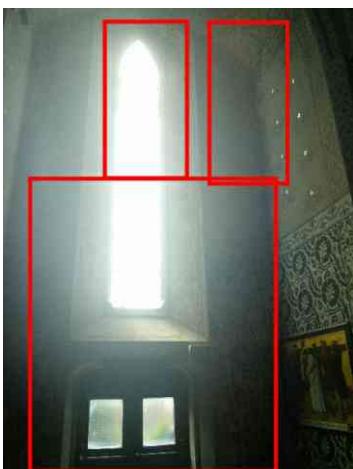
2.7.5 St Dominic's Chapel

Repair Priority: C - Up to 5 years

Condition: Needs Repair

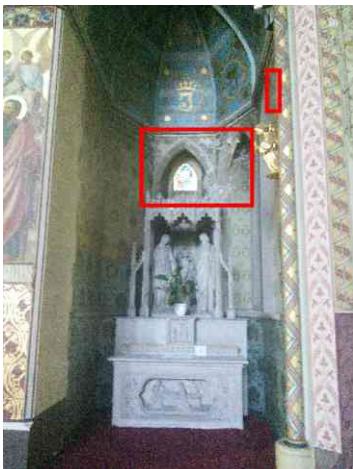
2.7.9 St Joseph's Chapel

Repair Priority: C - Up to 5 years

Condition: Needs Repair

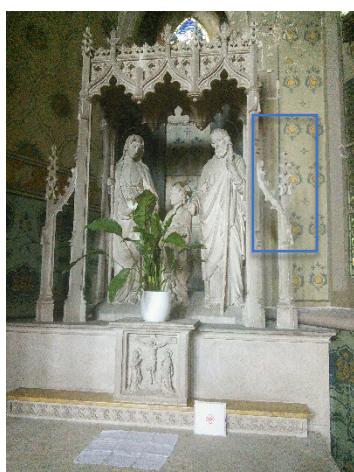
2.8.1 St Joseph's Chapel

Repair Priority: B - Up to 2 years

Condition: Needs Repair

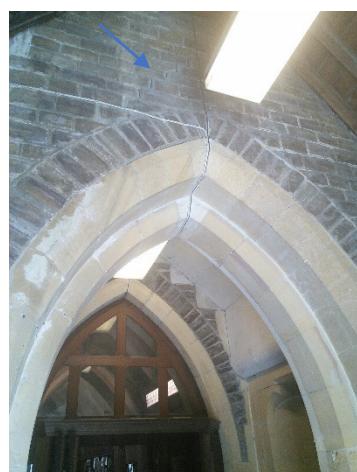
2.9.1 Southern Porch Interior

Condition: Needs Repair

Boarded timber ceiling, stone walls with Bathstone dressed stone, Terrazzo flooring. Old crack noted from head of the arch upwards.

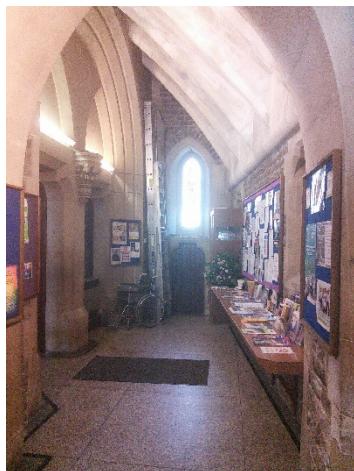
2.9.2 Narthex Interior

Condition: Fair

Stone ceiling, stone wall with Bathstone dressing and Terrazzo flooring. Ceiling cracks fixed since last quinquennium and no sign of return.

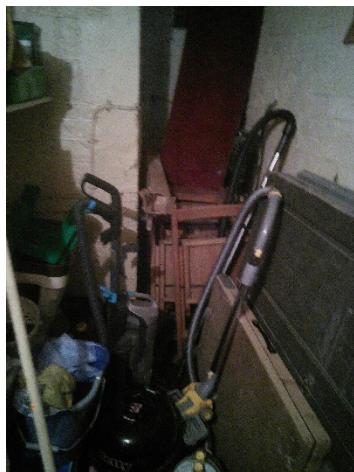
2.9.3 Narthex Cleaner's Cupboard

Painted stone and brick walls, rendered solid ceiling and concrete floor. Slightly musty smell.

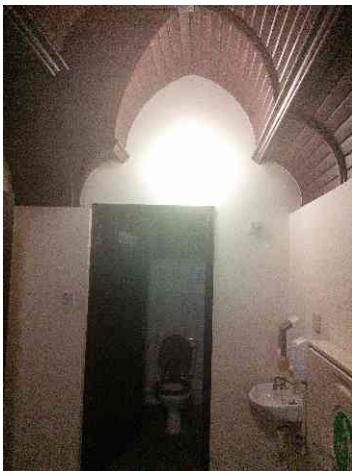
2.9.5 Toilets

Condition: Needs Repair

The old baptistery has been turned into a set of toilets. The wall to the Church in the hallway is suffering from damp. There is a wc cubicle and a disabled wc cubicle.

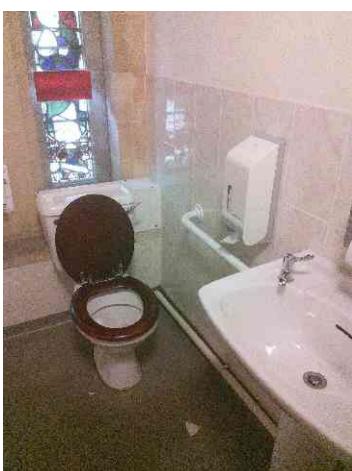
2.9.7 Toilet Two

Condition: Reasonable

Vinyl flooring, boarded roof tiles, half tiled walls with some paint peeling by the sockets noted

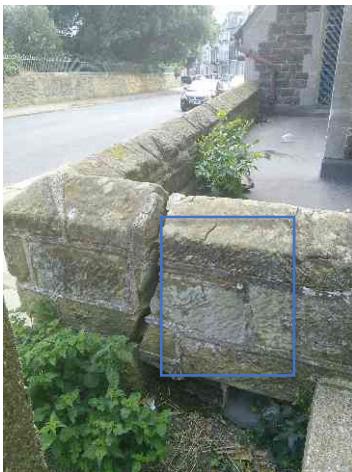
4.1.2 Wall above Cleaner's cupboard In narthex

Condition: Needs repair

Repair Priority: B up to 2 years

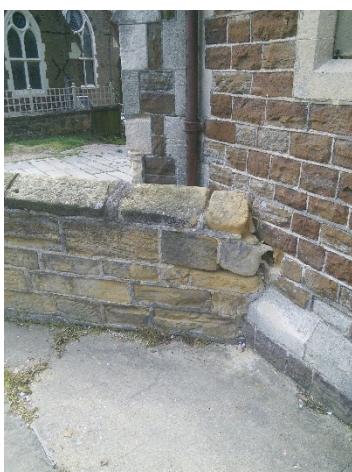
4.1.3 Wall by entrance

Repair Priority: C - Up to 5 years

Condition: Needs Repair

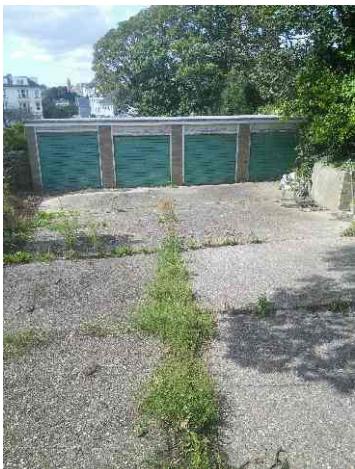
4.3.1 Drive Way to Garages

Repair Priority: M - Routine Maintenance

Condition: Needs Maintenance

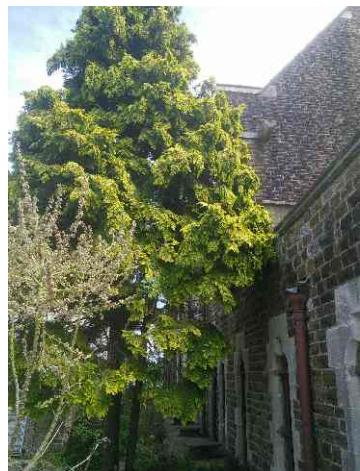
5.0.0 **Trees**

Along the front of the Church, the boundary to Magdalene Road at the northern end is formed by a low stone wall, which has been badly cracked by an old tree. Attempts to fill it have clearly been carried out in the past, but it is fighting back and needs removal and part of the wall rebuilt before it collapses. These walls also form the upper part of the cupboard off the Narthex. If the roots are not dealt with further damp problems could arise.

Repair Priority: D - Desirable Improvements

Condition: Needs Maintenance
