QUINQUENNIAL INSPECTION REPORT 2019

Location, Dedication	:	The Church of St Thomas of Canterbury & English Martyrs
Parish	:	The Parish of St Leonards-on-sea

Report Prepared by:
Nicholas Lee Evans
Lee Evans Partnership LLP
St Johns Lane
Canterbury
Kent CT1 2QQ

Inspection : August 2019

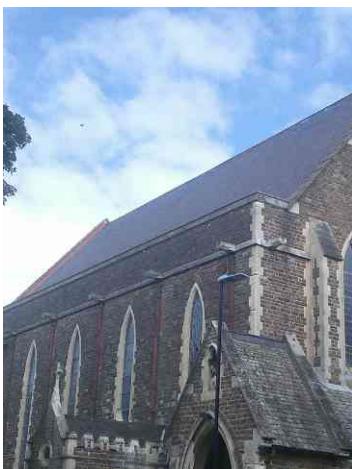
1.1.3 Main Roof South Slope

Repair Priority: B - Up to 2 years

Condition: Needs Repair

The south slope of the main roof is in better condition than the northern slope, but high up a few slates have been re-fixed with tingles in the past and there are areas where the roof has been patched. On the north side of the chancel arch, the paintwork on the south side is deteriorating low down, which suggests there is a problem with the haunching near the parapet wall. On both the north and south roofs there is a section of modern lead flat roofing.

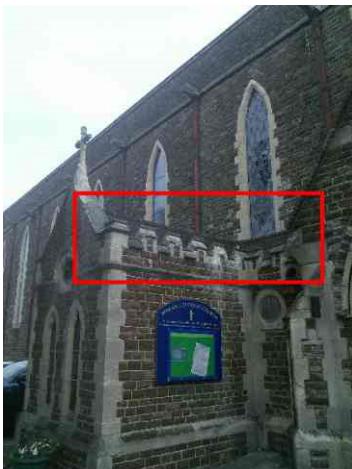
1.1.6 Roof over Toilets

Repair Priority: M - Routine Maintenance

Condition: Needs Maintenance

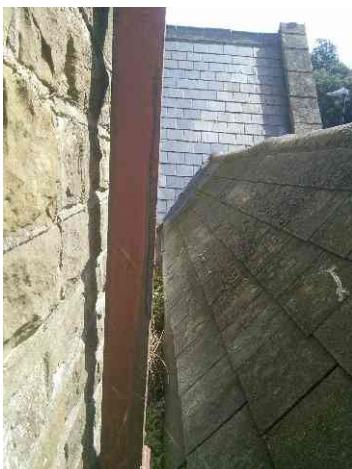
1.1.8 Valley between Toilet roof and South Wall of Church

Repair Priority: D - Desirable Improvements

Condition: Needs Maintenance

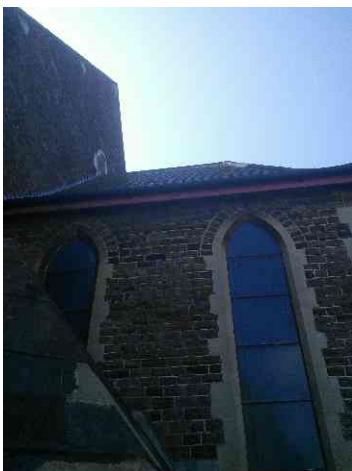
1.1.11 North Slope of the Chancel

Condition: Reasonable

Slate apsidal roof

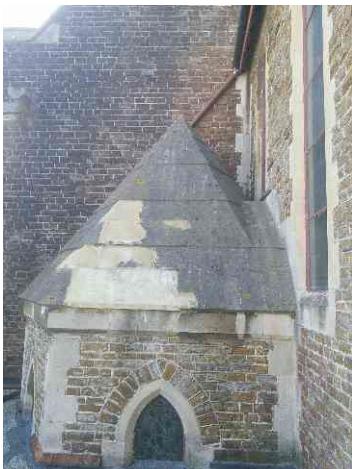
1.1.12 Roof over North Chancel Chapel

Repair Priority: O - Keep under observation

Condition: Fair

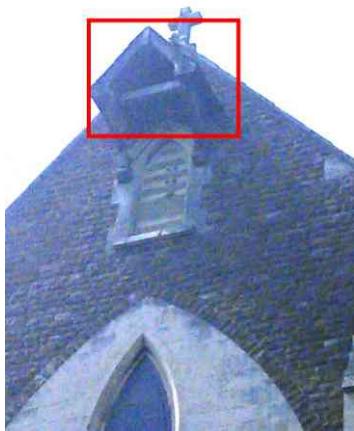
1.1.16 Old Bell Côte Roof

Condition: Reasonable

Slate covered oak roof where a bell would have hung in past.

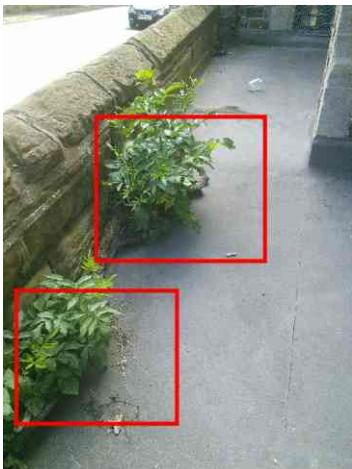
1.1.17 East Elevation Enclosure by Road

Repair Priority: M1 - Urgent maintenance

Condition: Needs Repair

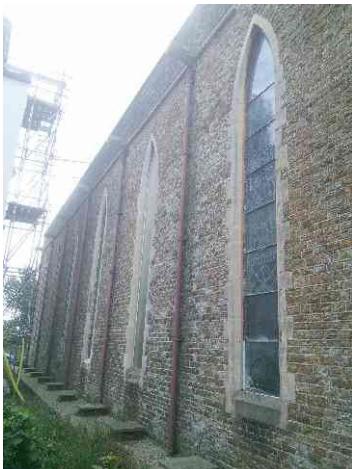
1.2.1 Rainwater Disposal Generally

Repair Priority: A – Urgent

Condition: Needs Repair

The main roof is drained by frequently spaced cast iron downpipes with stone overflows above each one. They need replacing or painting and this could be done when scaffold is up for re-pointing works. Many of the square gutters have old strap repairs, which suggest that they are nearing the end of their life. If major works are done to repoint the south wall and the paintings are repaired, I suggest it would be prudent to replace the downpipes. A stone overflow at the west end of the north elevation has fallen down and needs replacement.

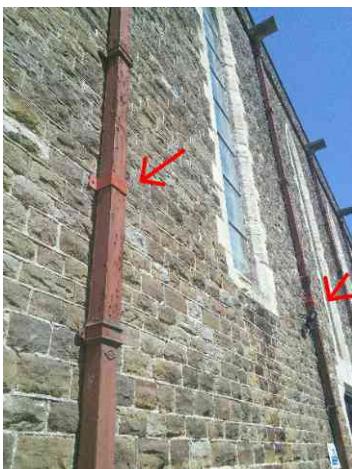
1.2.2 Repairs to a Southern Rainwater pipes

Condition: Fair

There have been a number of steel straps fitted to the southern rainwater pipes at different levels which I suspect are because of splits and repairs. As mentioned above, this together with the other faults on downpipes suggests they are starting to fail and need replacement soon. Damp from spilt rainwater pipes could be a significant reason why

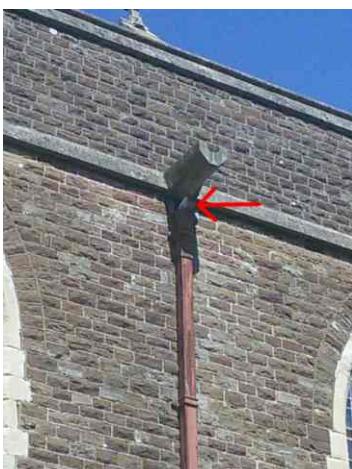
1.2.3 Pigeons

Pigeons are nesting at high level in the area of the overflows.

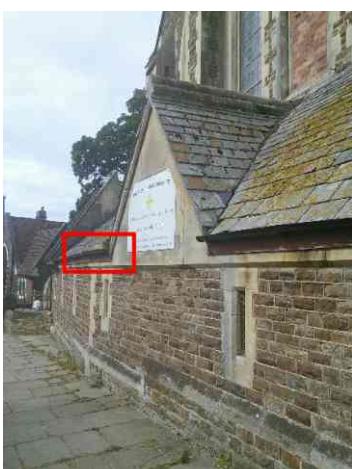
1.2.4 Narthex Roof

Repair Priority: C - Up to 5 years

Condition: Needs Repair

The narthex gutter is in black plastic and needs cleaning where plants are going out of it. The barge board needs minor repairs and redecoration all along the road.

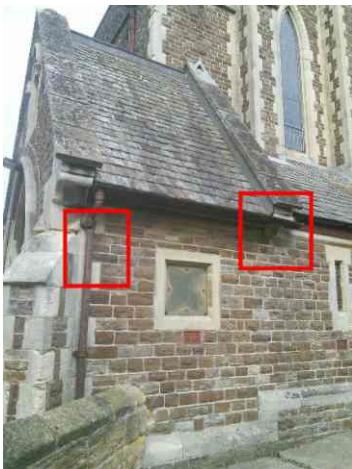
1.2.5 South Porch Gutter

Repair Priority: B - Up to 2 years

Condition: Needs Repair

On the road side of the south porch roof, the cast iron gutter needs decoration and the downpipe is broken and needs replacement. The gutter also tips backwards by the narthex roof and needs resetting.

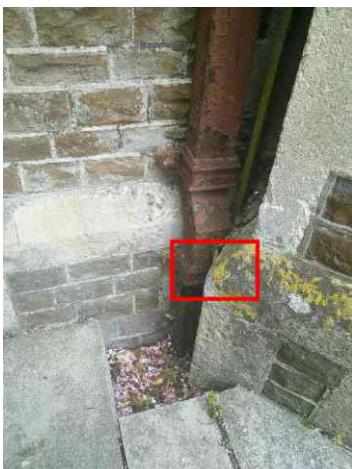
1.2.6 Rainwater Pipe In Corner of South Porch

Repair Priority: A - Urgent/ Up to 12 months

Condition: Needs Repair

The western downpipe of the toilet roof by the Church entrance is broken at its base. It needs replacement and decoration. The gulley needs cleaning.

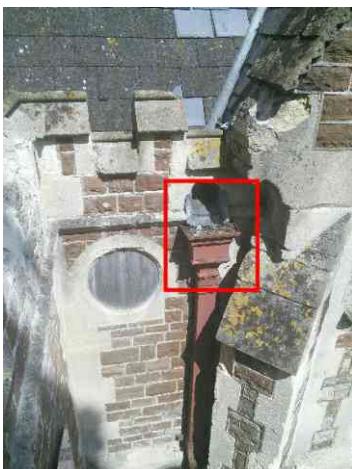
1.2.7 Hopper by South Porch by Toilets

Repair Priority: A - Urgent/ Up to 12 months

Condition: Needs Repair

The hopper by the south porch which drains the narrow parapet gutter around the shallow roof over the toilets off the narthex is blocked. Given the damage at the bottom of this rainwater pipe I think it needs taking down repairing, cleaning and redecorating.

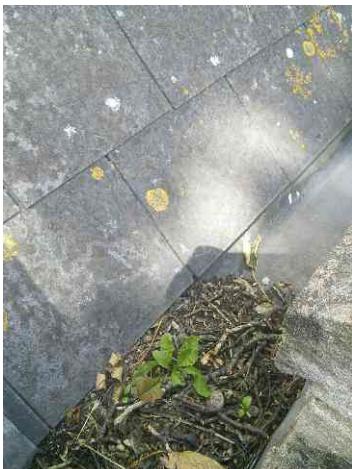
1.2.8 Shallow Parapet Gutter around Toilet Roof

Repair Priority: M1 - Urgent maintenance

Condition: Needs Maintenance

Photo of blocked gutter mentioned above.

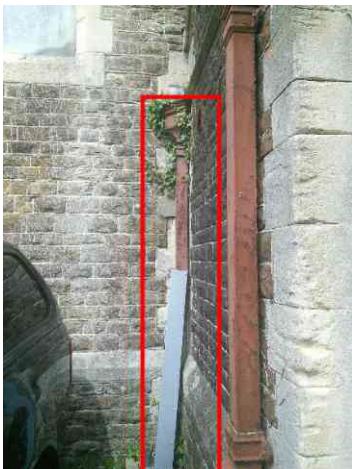
1.2.9 Rainwater Pipe for back gutter of Toilets against South Wall

Repair Priority: B - Up to 2 years

Condition: Needs Repair

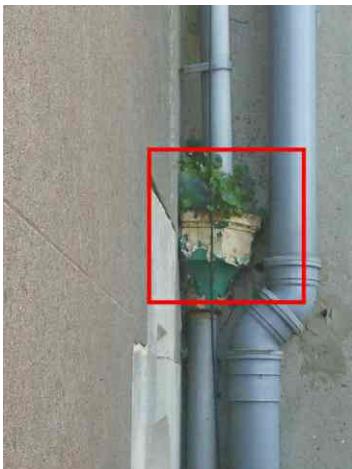
1.2.11 Rainwater Downpipe off Sacristy

Repair Priority: M - Routine Maintenance

Condition: Needs Maintenance

There are plants growing out of the hopper taking the rain water off the sacristy roof.

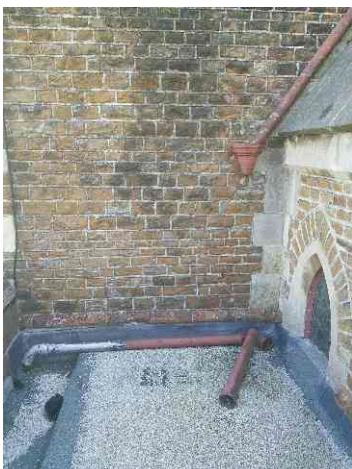
1.2.12 Rainwater Pipes onto Sacristy Roof

Repair Priority: A - Urgent/ Up to 12 months

Condition: Needs Repair

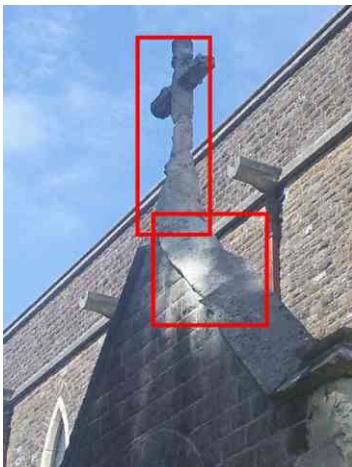
1.3.2 Southern Finial to Toilets

Repair Priority: B - Up to 2 years

Condition: Needs Repair

The cross-shaped finial on south elevation of Toilets has eroded to the point where it may not be stable in a high winds and needs repair. The eastern weathering stone is also badly decayed and in need of repair.

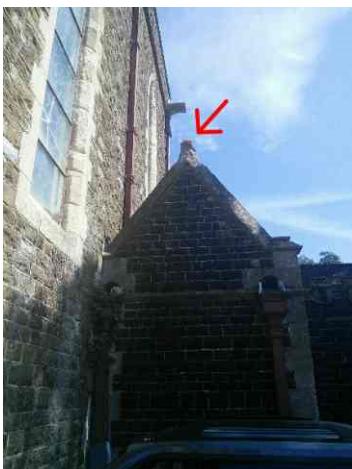
1.3.3 Western Finial to Toilets

Condition: Fair

Long eroded finial noted.

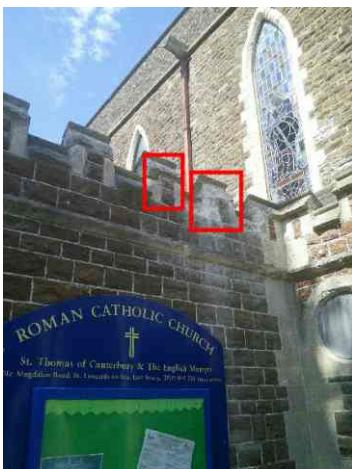
1.3.4 East Facing Crenulations To Toilets

Repair Priority: C - Up to 5 years

Condition: Needs Repair

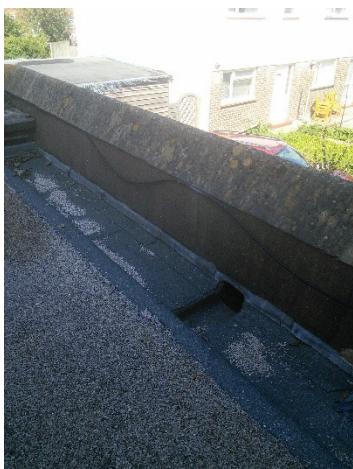
1.3.6 Sacristy North Parapet

Condition: Fair

Stone-capped low wall with rendered inner face.

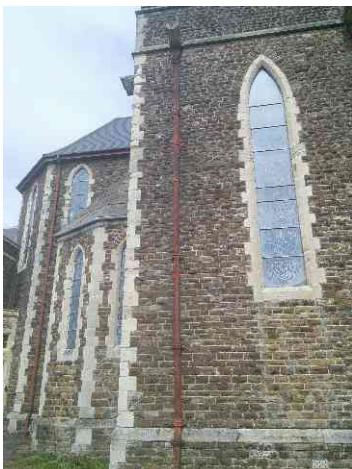
1.4.1 Walling Generally

As mentioned in the last quinquennium, the external stone walls are largely covered with hard cementitious raised pointing over the original lime pointing. This traps moisture driven into the walls, especially on the exposed western and southern sides by the sea winds.

The cement pointing, unlike the original lime pointing is not porous and I believe the moisture in the walls is drying out to the interior, leading to the exfoliation of the interior paint and plaster finishes.

Repair Priority: B - Up to 2 years

Condition: Needs Repair

The Church has been built of a hard ironstone which has been over-pointed with a cementitious raised pointing over the original lime pointing. The lime mortar underneath the cement pointing is soft. However, the cementitious ribbon pointing will be stopping the moisture, which soaks through the stonework after driving rain, drying to the outside. Instead it looks to be drying to the inside and making the plaster fail. I think this may be a significant contribution to the deterioration of the paintings inside. I strongly recommend that before the paintings are restored, the south and western elevations are repointed with a lime mortar. Preferably a "hot lime" mortar which has been shown to help keep old walls dry by absorbing moisture into the free lime in the mortar and only slowly releasing it.

English Heritage has already recommended these cement pointings are removed from the south and west walls for the sake of the future of the Westlake decorations. I strongly recommend this needs to be one the Parish's main objectives.

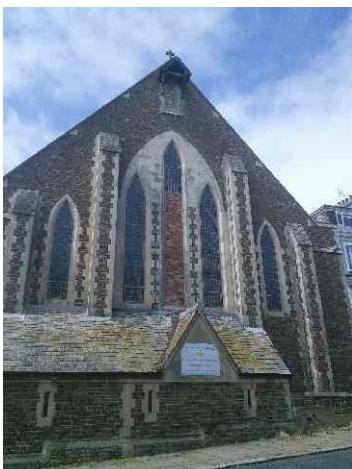
1.4.2 East Wall

Condition: Reasonable

Ironstone walls with original lime pointing still in place. The high gable is buttressed and has the narthex leant against it. The central window has been partially bricked in and there are some old horizontal cracks noted.

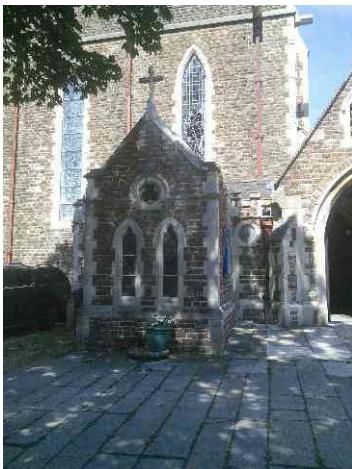
1.4.3 Toilet Walls

Condition: Fair

Ironstone with sandstone dressings.

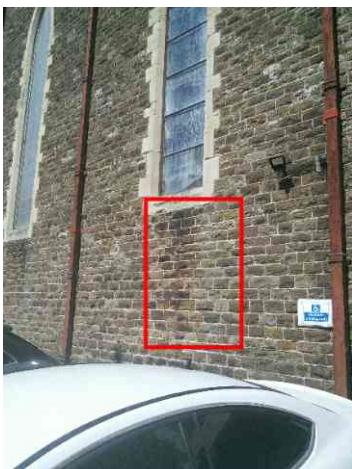
1.4.5 Staining below Southern Windows

Repair Priority: D - Desirable Improvements

Condition: Fair

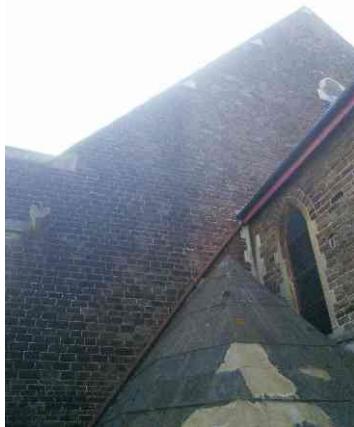
1.4.8 West Wall of the Nave

Condition: Fair

Lime-pointed ironstone wall. The pointing is soft and eroded in places.

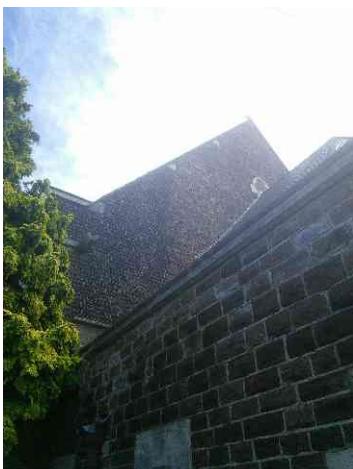
1.4.9 North side of West Nave Wall

Condition: Reasonable

Ironstone wall with lime pointing.

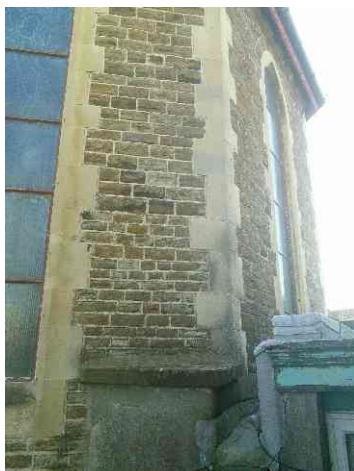
1.4.12 North side of Chancel Apse

Condition: Fair

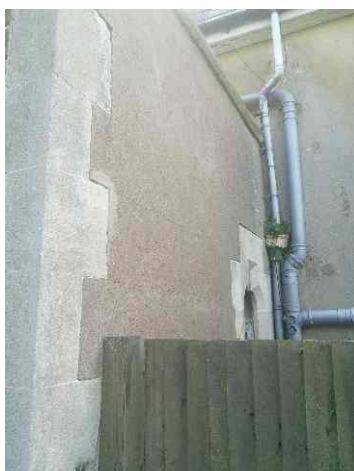
1.4.13 West Wall Sacristy

Condition: Reasonable

Rendered wall with stone quoins.

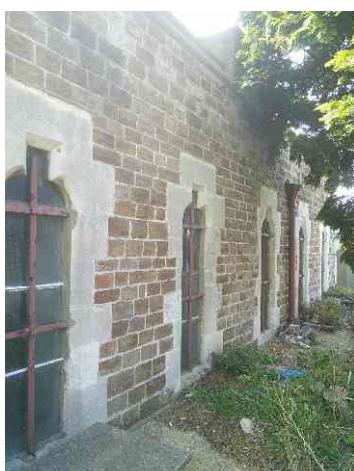
1.4.14 North Wall of Sacristy

Condition: Fair

Ironstone wall with stone dressings. The window cills are at ground level so the base of the walls in the sacristy are below ground level.

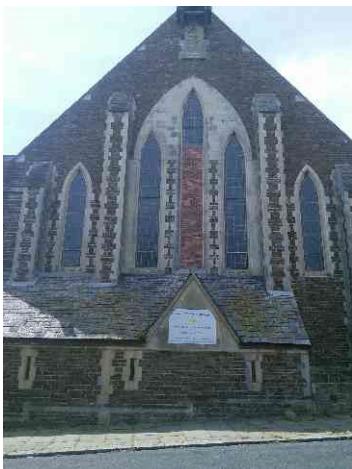
1.5.1 East Windows

Condition: Reasonable

Long lancet windows in Bathstone surrounds - central lancet blocked in.

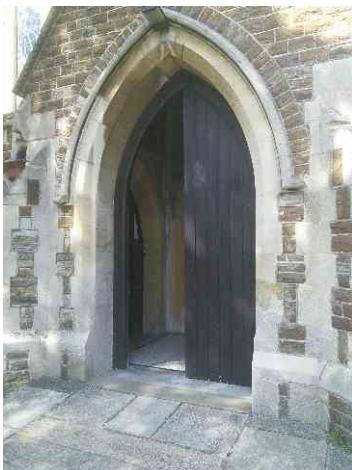
1.5.3 Porch Doors

Condition: Good

Timber-boarded doors.

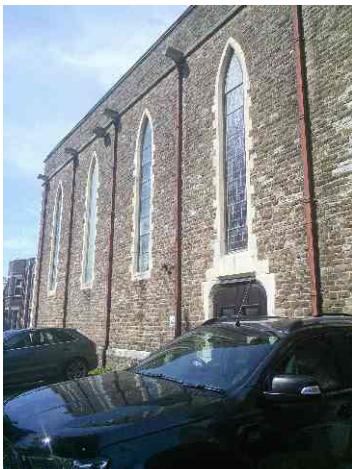
1.5.4 Southern Windows

Repair Priority: C – Repairs up to 5 years

Condition: C – Repairs up to 5 years

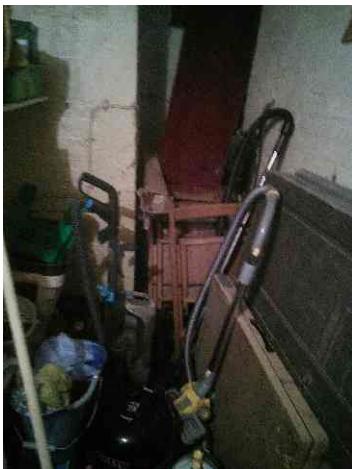
1.5.10 Cleaner's Cupboard off Narthex

Condition: Fair

Part underground cleaner's cupboard at the end of the narthex with painted stone walls, concrete floor and roof.

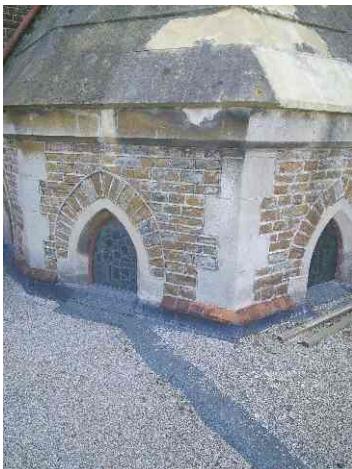
1.5.11 North Chancel Chapel Windows

Condition: Fair

It is noted that the windows cills around the north chapel in the chancel are at the same level as the roof of the sacristy, making weathering difficult

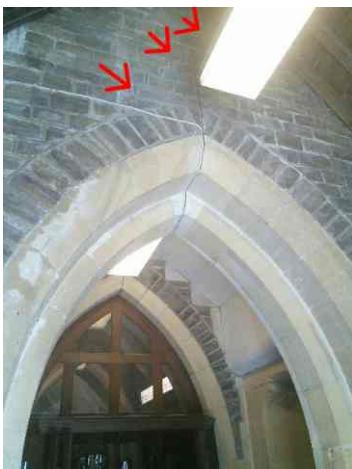
1.5.12 South Porch

Condition: Fair

Timber-boarded ceiling with exposed rafters and stone walls. From store opening granolithic floor with rotary flooring.

In the last quinquennium repairs were carried out to the narthex to stop the cracking showing in the south porch. Not a cause for concern at the moment.

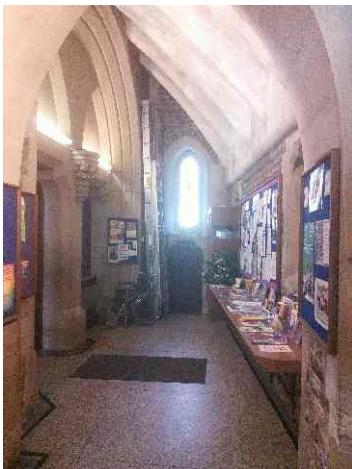
1.5.13 **Narthex**

Condition: Reasonable

Painted stone ceiling. Stone walls with noticeboards and granolithic flooring.

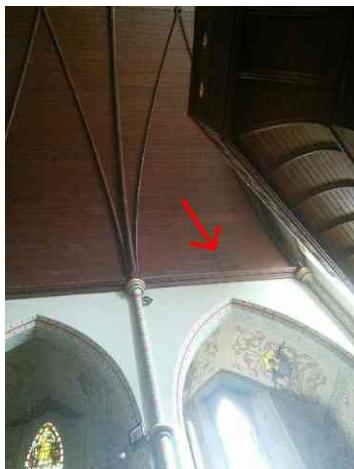
2.2.0 Roof and ceiling voids and ventilation

There is a small roof void down each space of the nave which is accessed from a door high up on the roof. I have not inspected these voids as they would need a scaffold tower to access them.

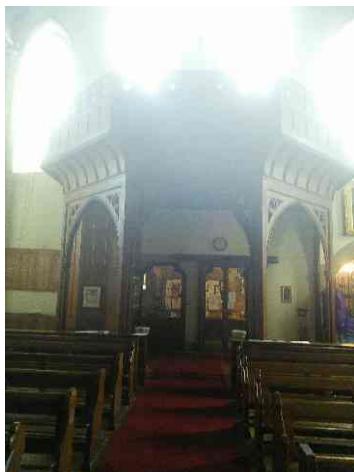
2.4.1 Gallery

Condition: Good

Large oak-framed gallery at west end which once housed an organ.

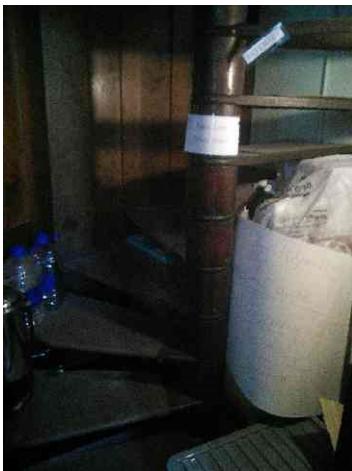
2.4.2 Gallery Stairs

Condition: Good

Timber spiral stair to gallery with storage under. If the gallery is used the materials stored here and should be removed in case of fire.

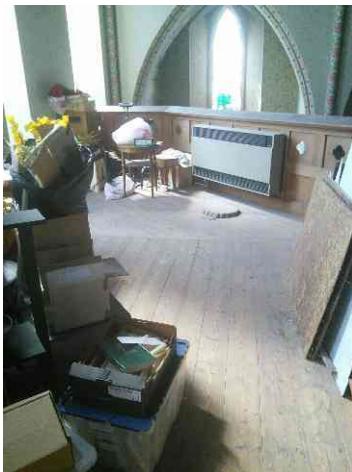
2.4.3 Gallery Store

Condition: Fair

Gallery used for storage. Timber floor and balustrade. There is no view of the chancel if one was sitting down in the gallery.

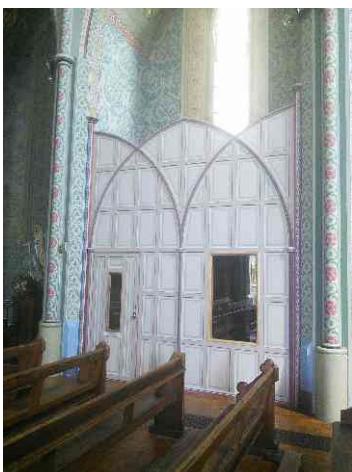
2.5.1 Confessional Screen

Condition: Good

Painted timber paneling

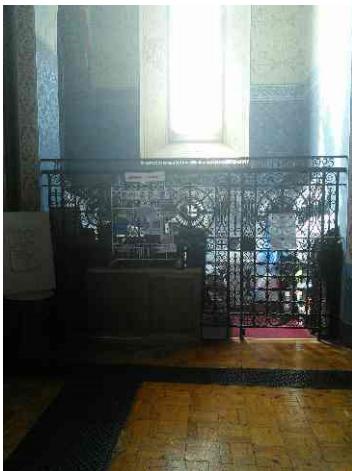
2.5.2 Repository Screen

Condition: Good

Part-gilded wrought iron screen dated 1925

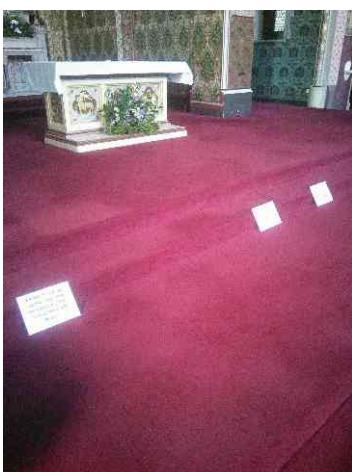
2.6.2 Chancel Floor

Condition: Good

Chancel floor carpeted. I suspect there is a good stone or tiled floor below the carpet.

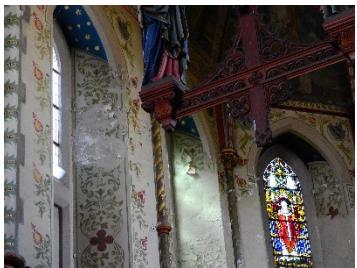
Repair Priority: C - Up to 5 years

Condition: Needs Repair

Sanctuary walls and finely decorated with angels and biblical scenes. Above the level of the dado rail the condition of the wall deteriorates on the south side between the windows. Lime plaster showing and paint peeling.- sources of damp need attention and then re-stenciling.

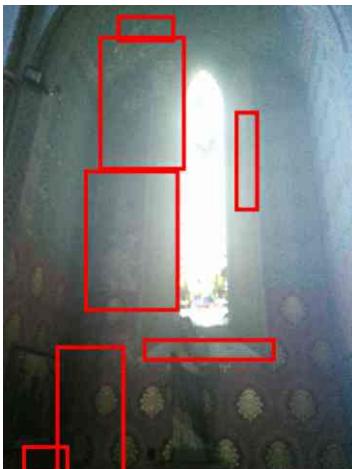
2.7.6 Sacred Heart Chapel

Repair Priority: C - Up to 5 years

Sacred Heart Chapel: Crazed and peeling paint low down on east side, with hard white plaster behind. Higher up on east side pink plaster and efflorescence showing through. Some decay on both sides of window reveal, head of window and eastern arch.

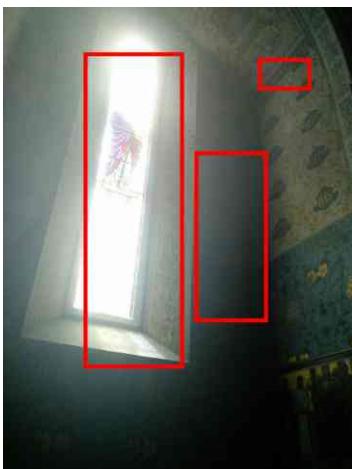
2.7.7 St Ignatius Chapel

Repair Priority: C - Up to 5 years

Condition: Needs Repair

St Ignatius Chapel: Failing plaster and crazing in window reveals and on wall on the western side by window. Also low down on western side. Plaster looks to be whiter. Most paintwork good. West arch, high up, peeling. Pink plaster in window reveals.

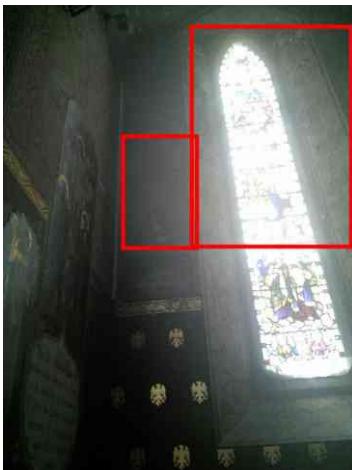
2.7.8 St John's Chapel

Repair Priority: C - Up to 5 years

Condition: Needs Repair

St John's Chapel: Plaster failing in window reveals and sill and to south side of east wall by painted Calvary on wall. Where the plaster is best it has a base of a lime plaster, but where it is failing, hard pink plaster has been used.

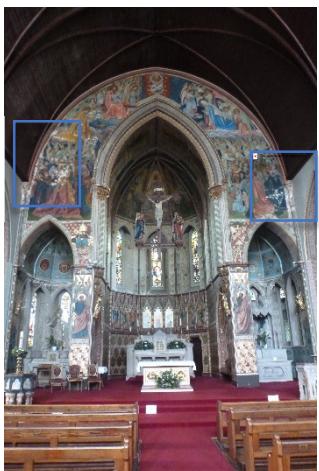
2.7.10 Chancel Arch

Repair Priority: C - Up to 5 years

Condition: Needs Repair

Chancel Arch: Westlake painting failing below ceiling where we suspect haunchings are failing, between parapet and slates. Damp problem to north side is a known problem but is similar to the south which the roofers have reported.

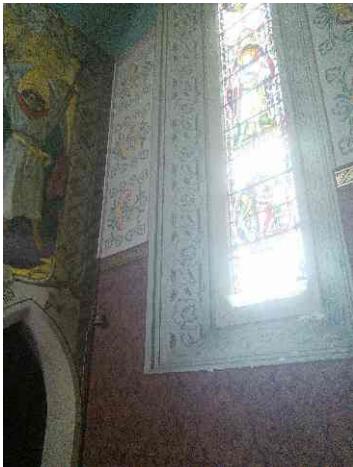
2.7.11 St George's Chapel Northside

Repair Priority: C - Up to 5 years

Condition: Needs Repair

St George's Chapel: Generally, in good condition, but for a few minor losses of plaster low down and on the cill of hard white lime plaster.

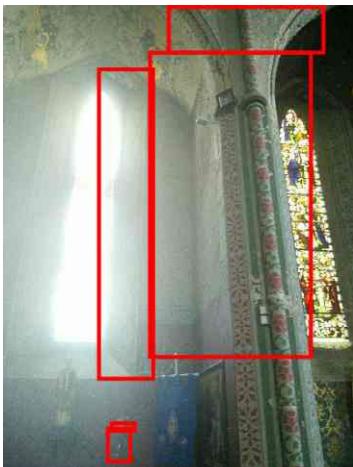
2.7.12 St Thomas of Canterbury Chapel

Repair Priority: C - Up to 5 years

Condition: Needs Repair

St Thomas of Canterbury Chapel: Plasterwork suffering from salts on eastern side coming down from top. West side good suggestive of a top down leak. I suspect the failed rainwater chute outside is part of the problem here.

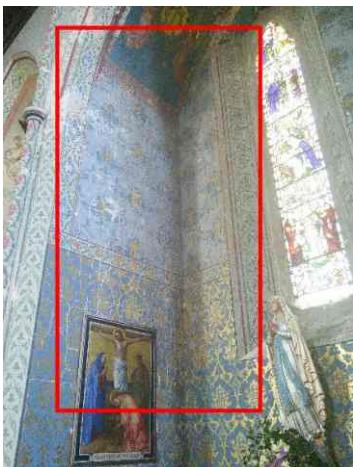
2.7.13 Our Lady Of Lourdes

Repair Priority: C - Up to 5 years

Condition: Needs Repair

Our Lady of Lourdes: The other side of the St Thomas Chapel the walls are badly crazed and efflorescence is attacking the walls. There are some pink plaster repairs and some in a hard lime plaster. All on the west and east side are good. Efflorescence on the gold more than the paint where it cannot breathe.

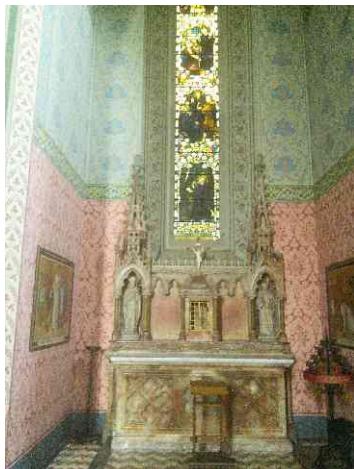
2.7.14 St Leonard's Chapel

Condition: Fair

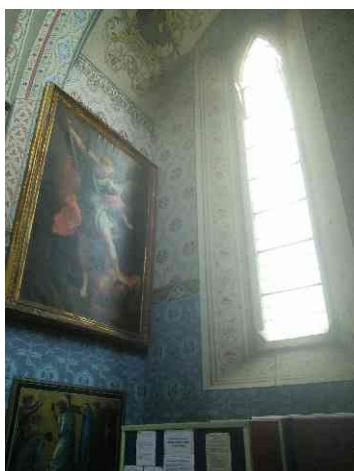
2.7.15 Chapel of the Holy Soul

Condition: Reasonable

Good

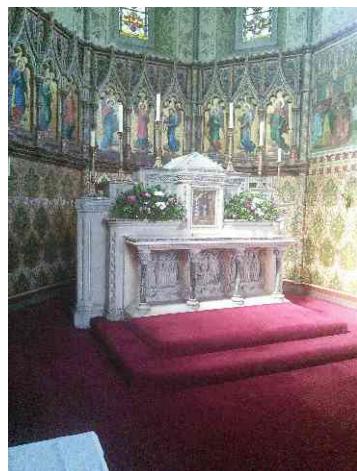
2.8.2 Altar

Condition: Good

Carved stone and marble tabernacle

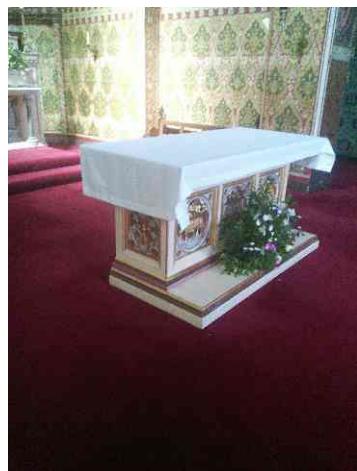
2.8.3 Main Altar

Condition: Good

Relatively modern altar

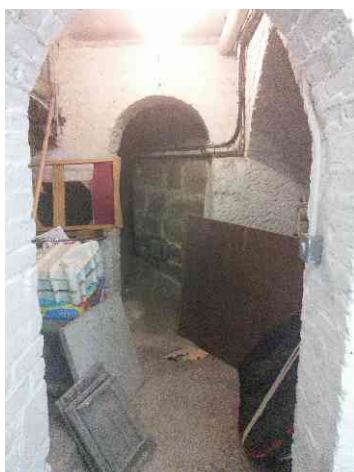
2.9.4 Undercroft

Condition: Fair

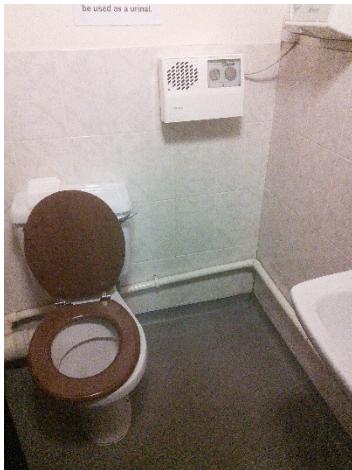
2.9.6 Toilets Cubicle

Repair Priority: M - Routine Maintenance

Condition: Needs Maintenance

Loose toilet seat in WC.

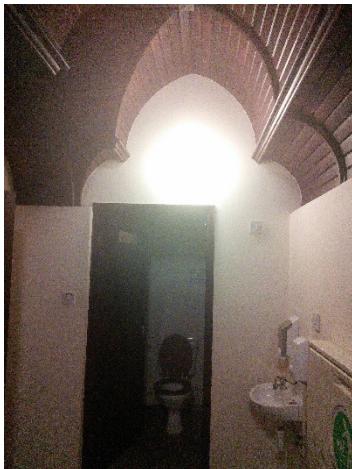
2.9.8 North Toilet Vestibule Wall

Repair Priority: C - Up to 5 years

Condition: Needs Repair

Before work is carried out to repair this, I suggest the gutter above is widened to stop water getting into the drylining. I also recommend vents are fitted in this drylining.

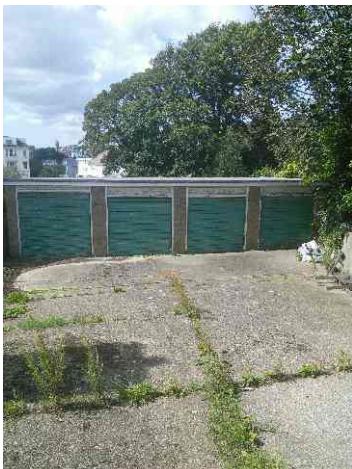
2.9.9 Garages

Condition: Fair

Brick garages and garden stores with felt flat roof. Locked and not inspected inside.

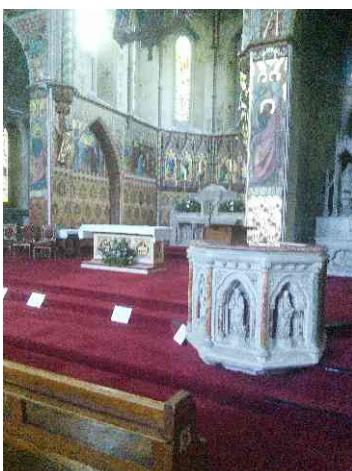
2.10.1 Chancel Furniture

Condition: Good

The Church has a stone font and pulpit, as well as a stone altar and tabernacle. All in good condition. The pulpit has been dropped.

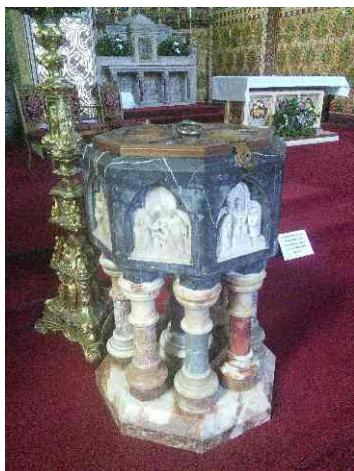
2.10.2 Font

Condition: Good

The font sits to one side of the dais.

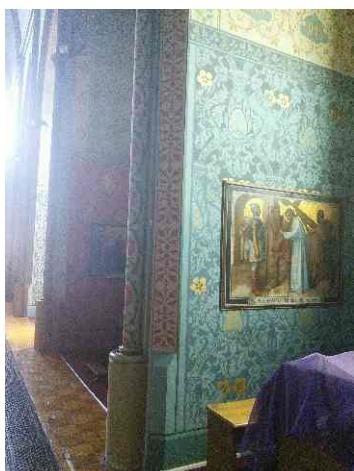
2.10.3 Stations of the Cross

Condition: Good

Painted stations of the cross

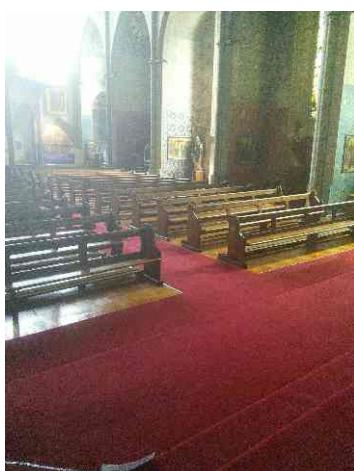
2.10.4 Pews

Condition: Reasonable

Simple oak pews contemporary with the building.

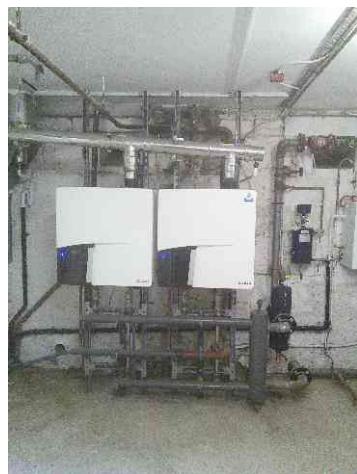
3.1.0 Heating

Condition: Good

Modern gas fired boilers in a dry basement running large bore pipework in trenches in the Church floor.

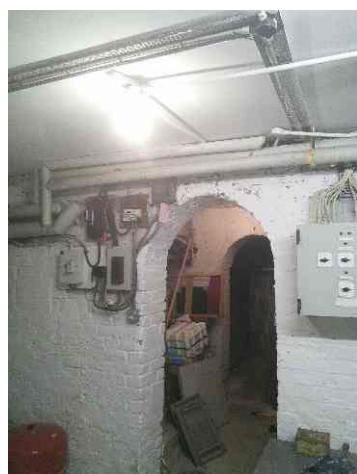
3.2.0 Electrical

Condition: Reasonable

The Church has an electrical system which is regularly tested.

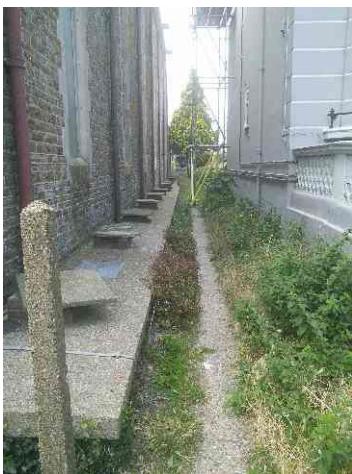
4.1.1 Northern Boundary

Condition: Fair

The northern boundary is formed by an open passageway and a neighbour's wall.

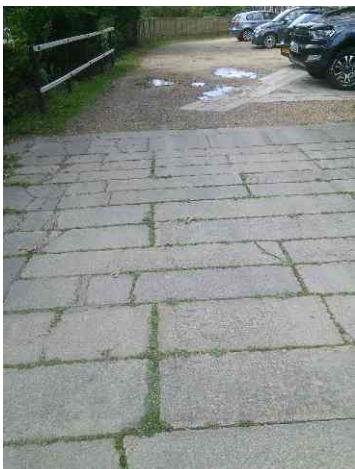
4.2.1 Access way

Condition: Fair

The Church has a few car spaces inside the Church grounds with gravel or concrete slab pavings.
