## QUINQUENNIAL INSPECTION REPORT 2021

Location, Dedication	:	The Church of The Holy Redeemer
Parish	:	The Parish of The Good Shepherd, St Leonards-on-Sea

Inspection : 25<sup>th</sup> June 2021

First Issue 30<sup>th</sup> August 2021

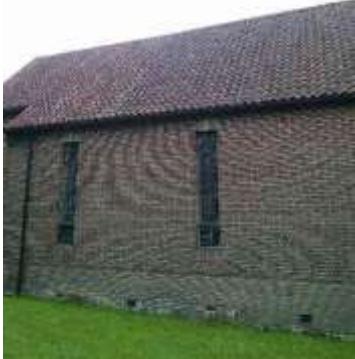
#### 1.1.2 **West Roof Over Nave**

**Condition:** Good

Clay pantile roof and clay ridge tile.

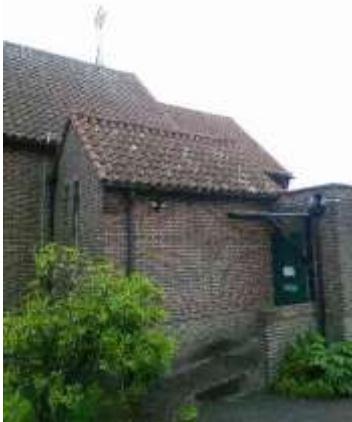
**Condition:** Good

Clay pantile roof and clay ridge tiles.

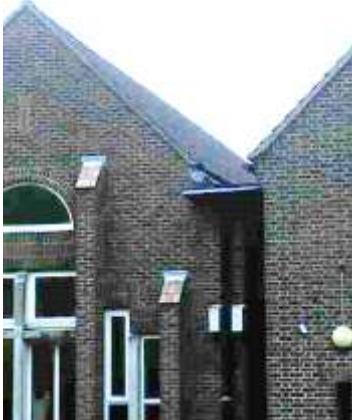
#### 1.1.7 Chancel Roof West Slope

**Condition:** Good

Concrete pantiles and ridge.

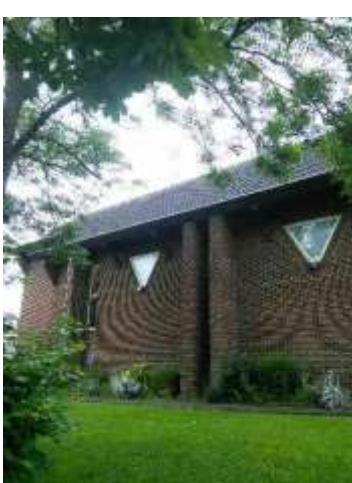
#### 1.1.8 Chancel East Slope

**Condition:** Good

Concrete Pantiles with isolated chipped tiles noted.

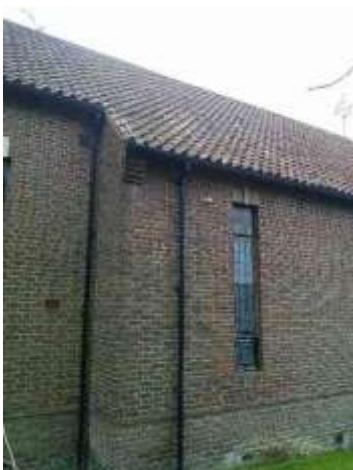
### 1.2.2 Rainwater Goods To Old Church

**Repair Priority:** C - Up to 5 years

**Condition:** Reasonable

Cast iron gutters with cast iron and plastic downpipes which will need painting in next quinquennium or late this quinquennium.

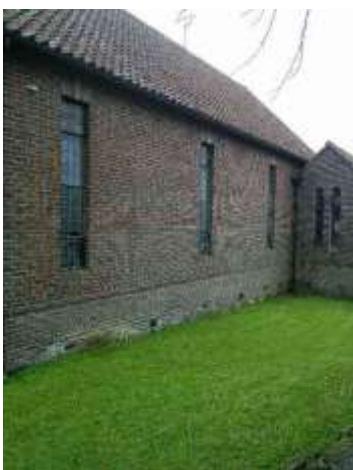
#### 1.3.1 Walling To Old Church

**Condition:** Reasonable

Well pointed red stock brickwork

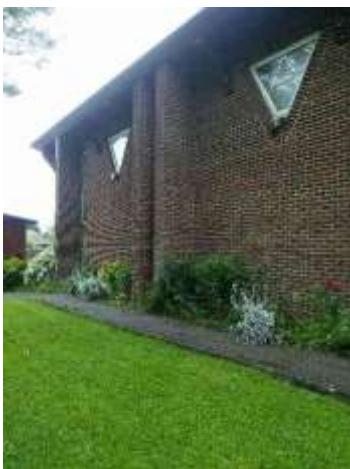
### 1.3.3 Walling To Chancel Extension

**Condition:** Good

Brick walls with brick buttresses all built in red stock face bricks.

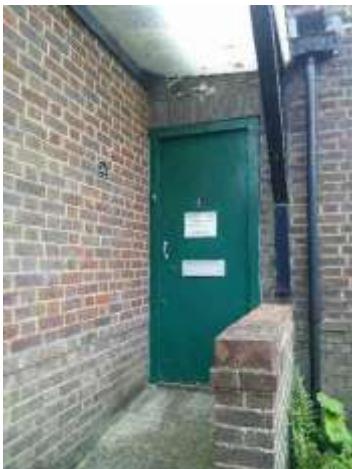
#### 1.4.4 Sacristy Door

**Condition:** Reasonable

Painted wooden door with scuffed decorations.

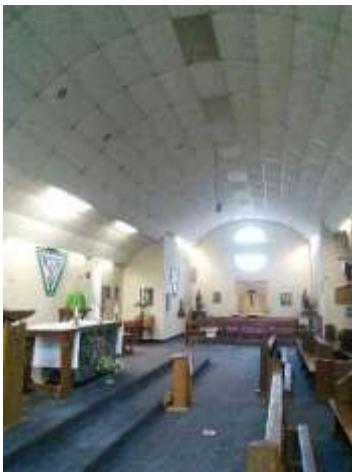
#### 2.1.1 Chancel Ceiling

The main body of the Church has a barrel vaulted suspended ceiling which is generally in good order except for a couple of minor old water stains noted towards the Gallery on the north side the Church. It would be desirable to replace the affected ceiling tiles.

**Condition:** Reasonable

Barrel vaulted suspended ceiling which hides the roof structure over.

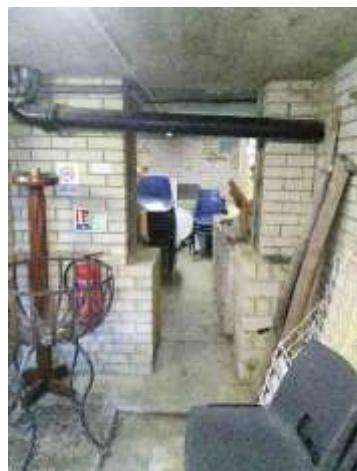
## 2.6.7 Under-Croft

**Condition:** Reasonable

Concrete ceiling and floor , calcium silicate brick and block walls.

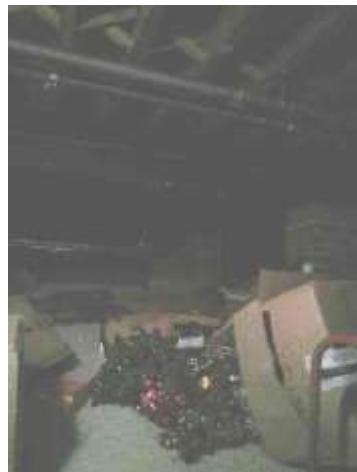
## 2.6.8 Void Under Church Floor

**Repair Priority:** D- Desirable Improvement

**Condition:** Reasonable

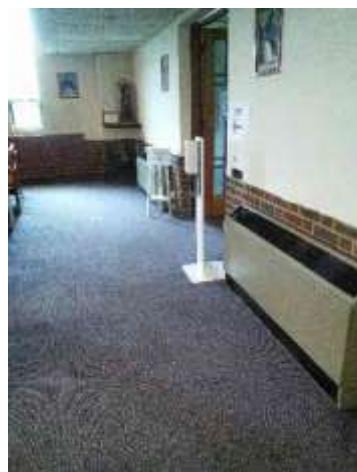
### 3.1.0 Heating

**Condition:** Reasonable

Heat Emitters: Mix of blown air and radiators distribute heat from gas boiler in basement.

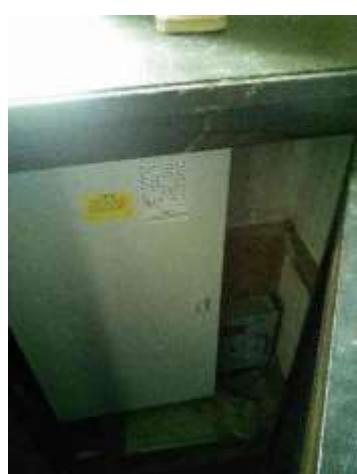
#### 3.2.2 Electrical

**Condition:** Good

Electrical periodic test recently completed.

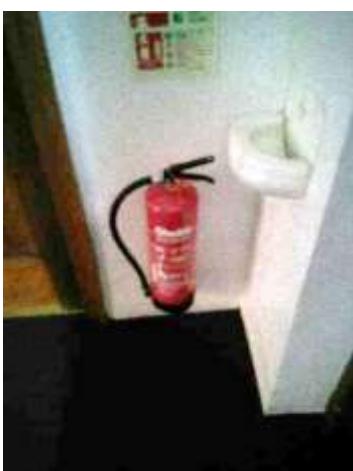
### 3.6.0 Fire Protection

**Repair Priority:** M - Routine Maintenance

**Condition:** Good

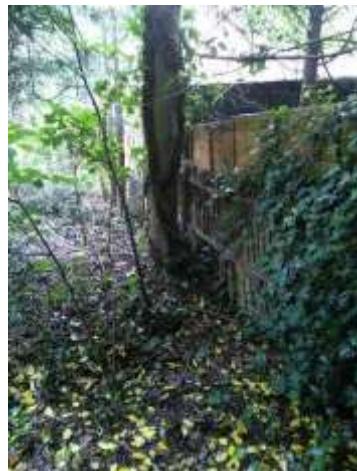
#### 4.1.2 South Boundary

**Condition:** Reasonable

Modern fencing with some ivy starting to grow on it, which needs to be kept in check.

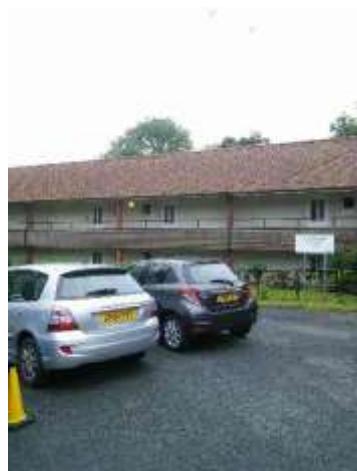
#### 4.1.3 South West Boundary

**Condition:** Reasonable

St Vincent's Flats form the southern boundary.

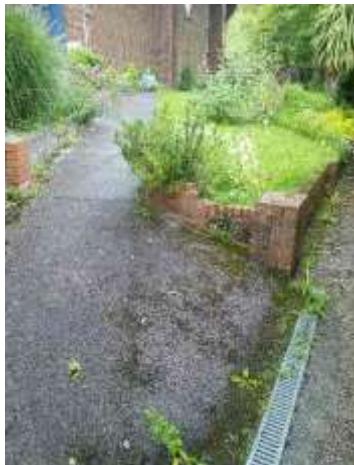
### 4.2.2 Paths Generally

**Repair Priority:** M - Routine Maintenance

**Condition:** Needs Maintenance

Paths: Mix of tarmac and concrete paths with low retaining walls. Some cracking to surfaces of paths. Plants growing in path cracks need killing with systemic weed killer and cracks patched where they are becoming a trip hazard.

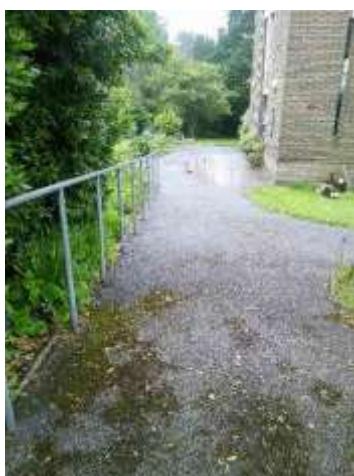
### 4.2.3 Access

**Condition:** Reasonable

The Church has ramped access with handrails leading to entrance.

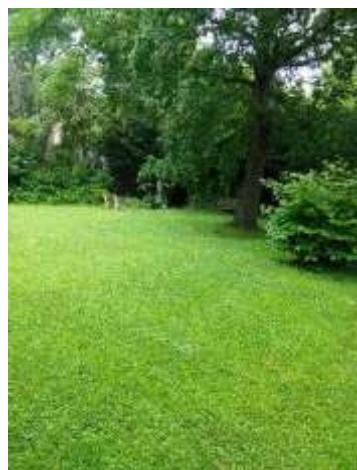
##### 4.3.1 Gardens

**Condition:** Good

Attractive well maintained gardens surround the Church.

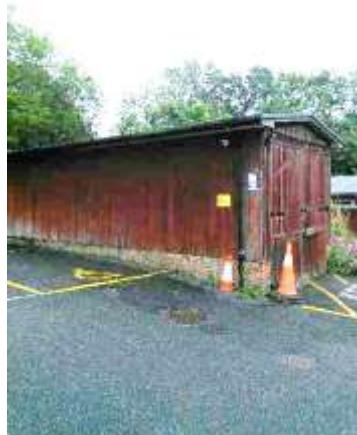
**Repair Priority:** C - Up to 5 years

**Condition:** Needs Repair

Garage: Felt roofed, with painted and stained barge boards, timber framed structure on brick base of similar lightweight construction as hall. Stained boarded walls need decoration as do windows which also need putty repairs to glazing. There is a missing timber rail on one of the doors which needs repair.

4.3.2	Garage: Felt roofed, with painted and stained barge boards timber framed structure on brick base of similar lightweight construction as hall. Stained boarded walls need decoration as do windows which also need putty repairs to glazing. There is a missing timber rail on one of the doors which needs repair.	£2000
<b>Item</b>	<b>D: Items to which improvement is desired</b>	<b>Budget Cost</b>

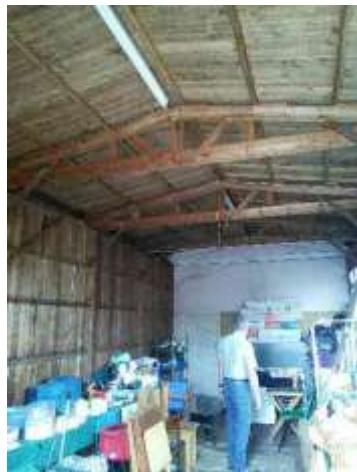
#### 4.3.3 Old Garage

**Condition:** Fair

Concrete floor with sunken pit in floor with timber boards over. Stud walls with shelving and used for storage.

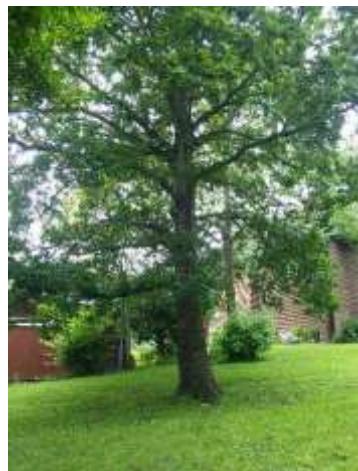
## 5.0.0 **Trees**

**Repair Priority:** M - Routine Maintenance

**Condition:** Fair
